the **play inspection** company

Annual Inspection

Babergh District Council

Sproughton Playing Fields

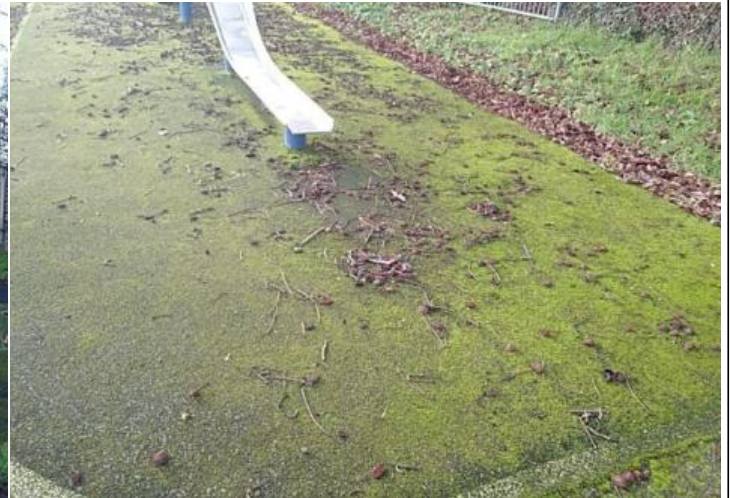
Finding: There is algae, silt or moss growth on the surface resulting in slippery conditions

Action: Clean and treat appropriately

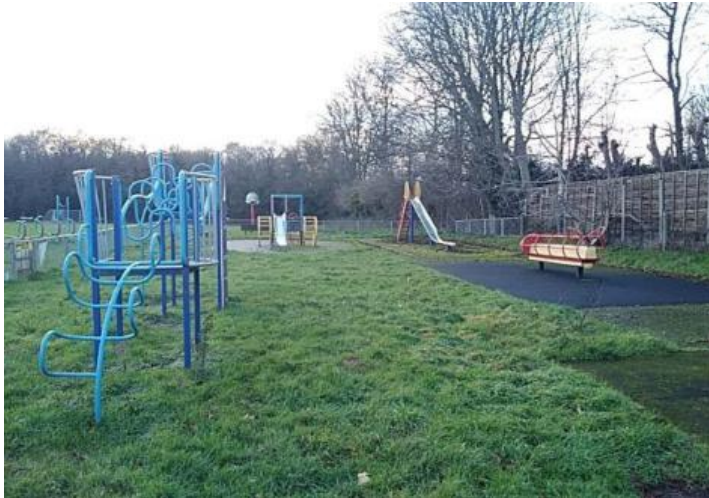
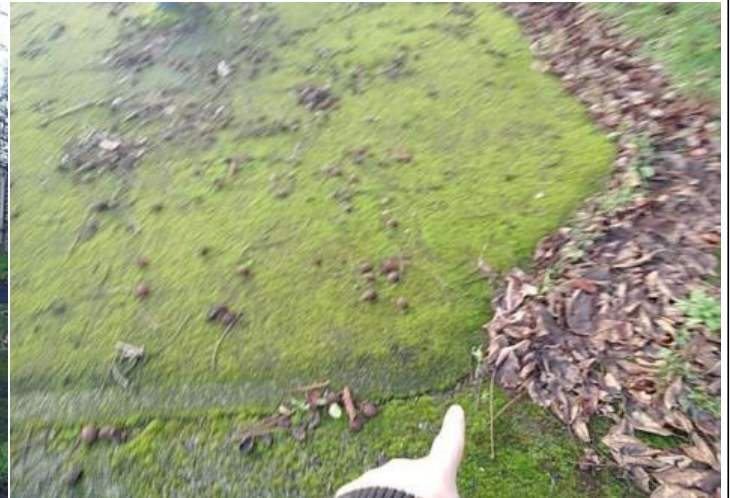
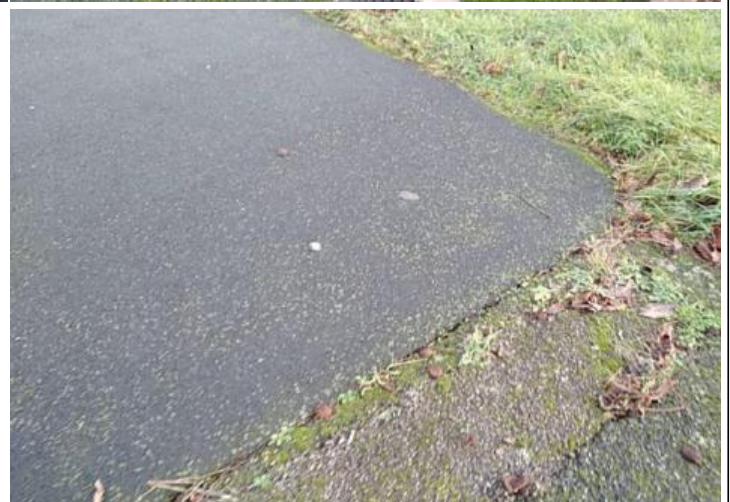
Finding: The surface is lifting at the edges and creating trip points **Action:** Repair perimeter of surfacing to remove trip points

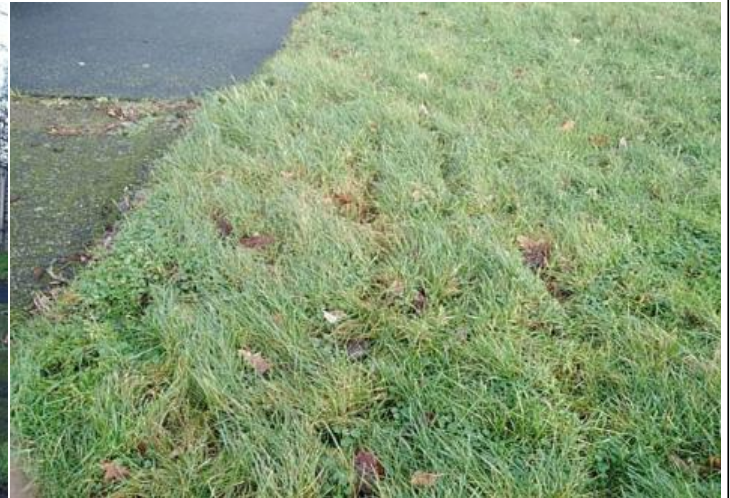
Finding: The grass is overgrown within the play area and may hide hazards

Action: Reduce the length of grass to an acceptable height and maintain

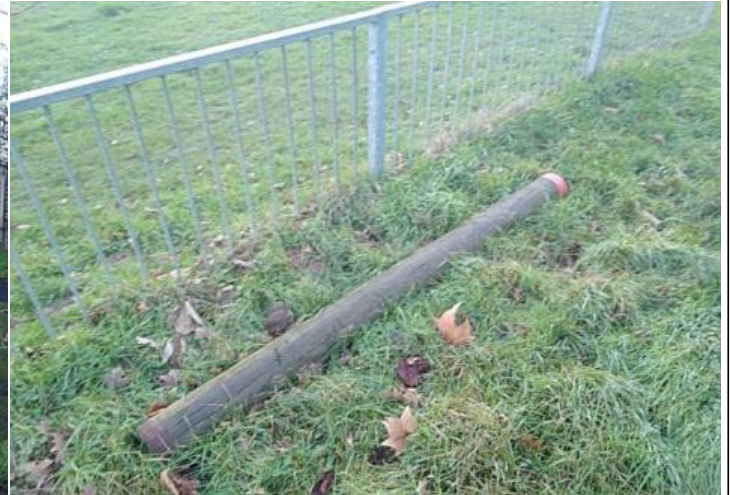
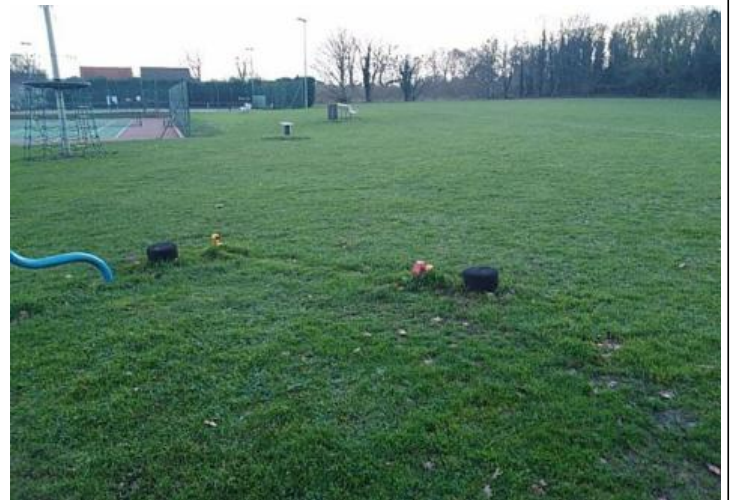
Finding: The rotating beam has been removed from the activity trail and has been left in the play area

Action: Repair damaged section of the activity trail

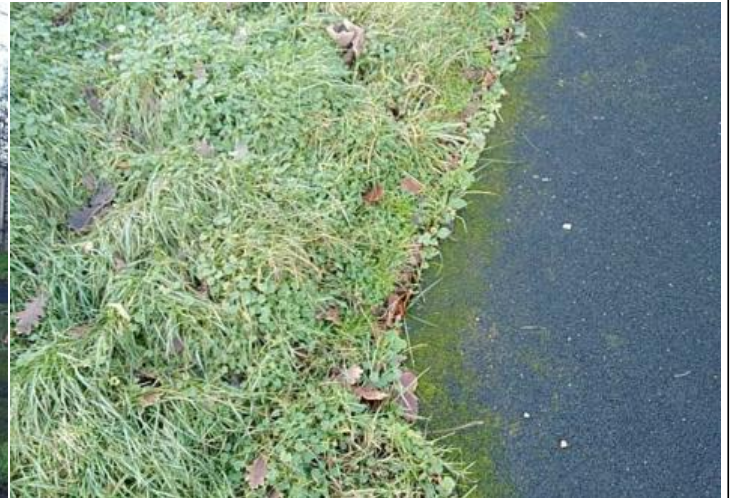
Finding: There are significant gaps (over 30mm) between the surface and the edging or between the joints in the surface; these are large enough for a small foot to enter

Action: Repair surfacing

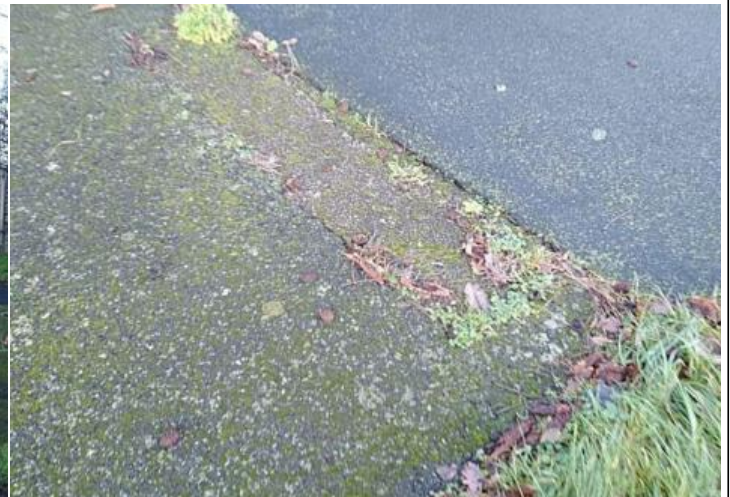
Finding: There is damage to the tarmac surface

Action: Repair the damaged areas of surfacing

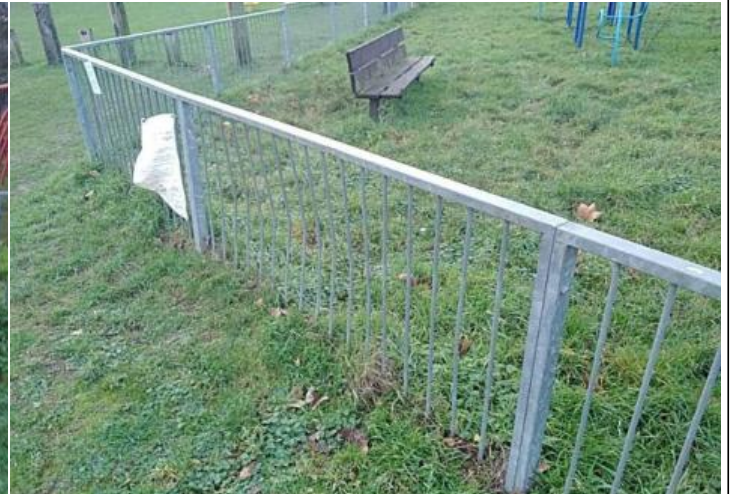
Finding: There is some damage to the fence sections

Action: Monitor for any further deterioration and repair as required

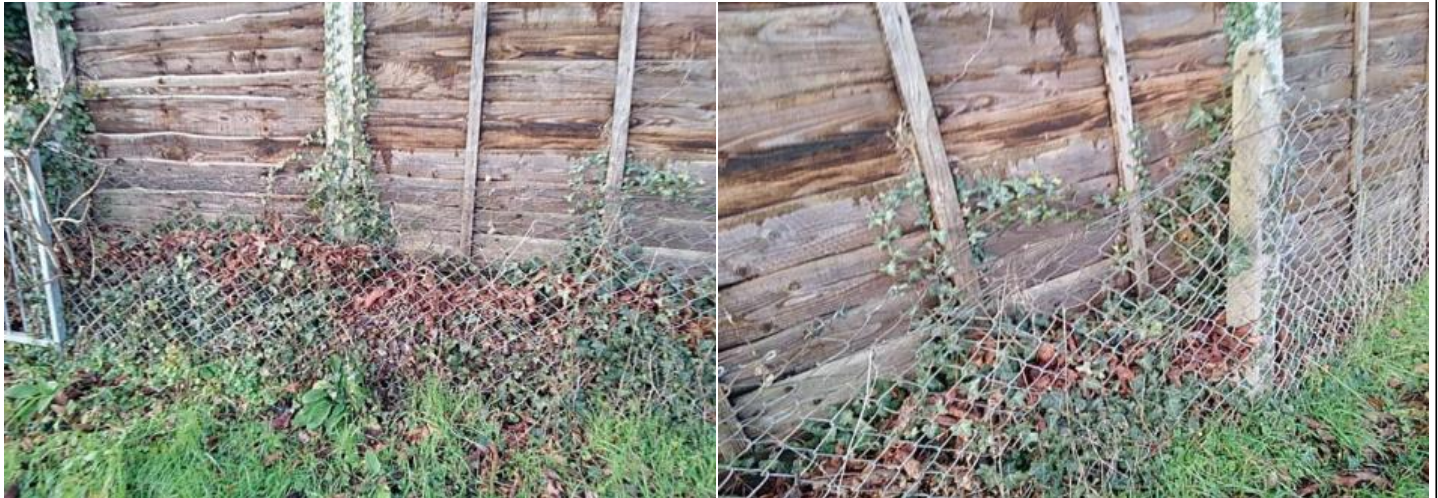
Finding: The fence is damaged in places

Action: Repair or replace all affected sections

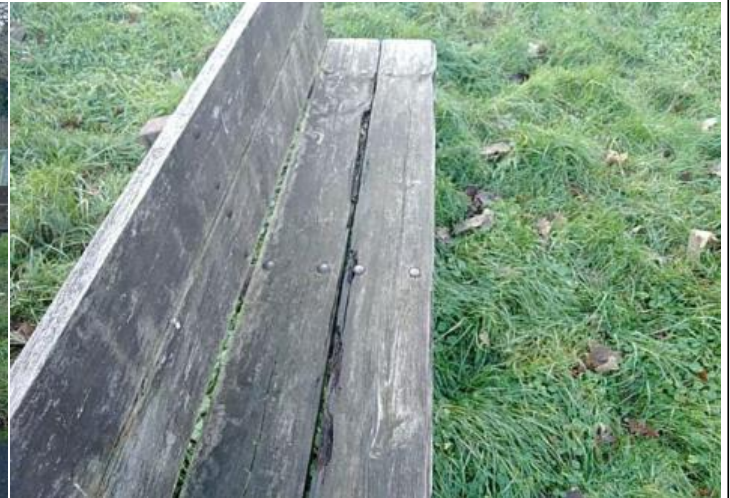
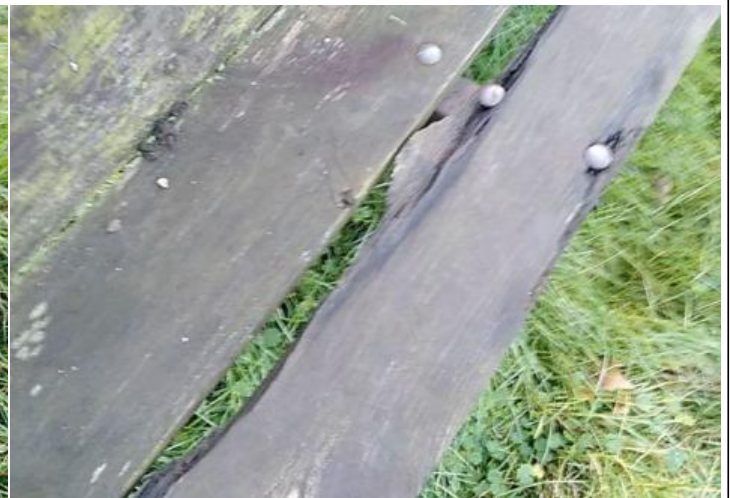
Finding: There are areas or parts of the timber on the structure that have rotted

Action: Replace all affected timbers

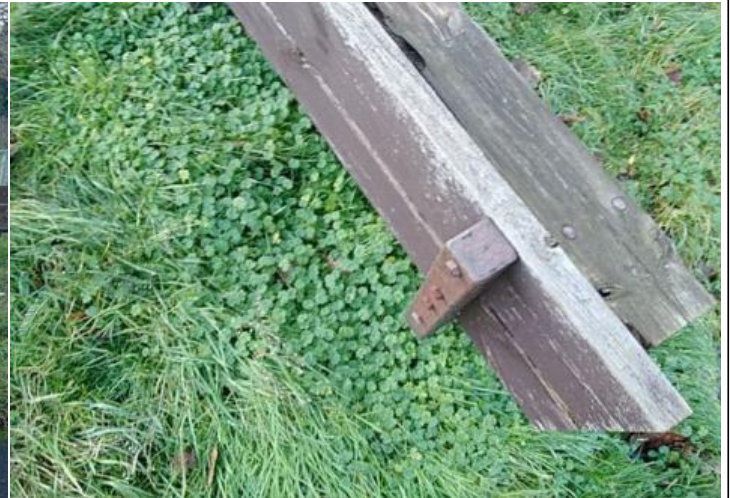
Finding: The paintwork on this item has been damaged or worn exposing the metal underneath which is rusting

Action: Treat any rusting components and repaint

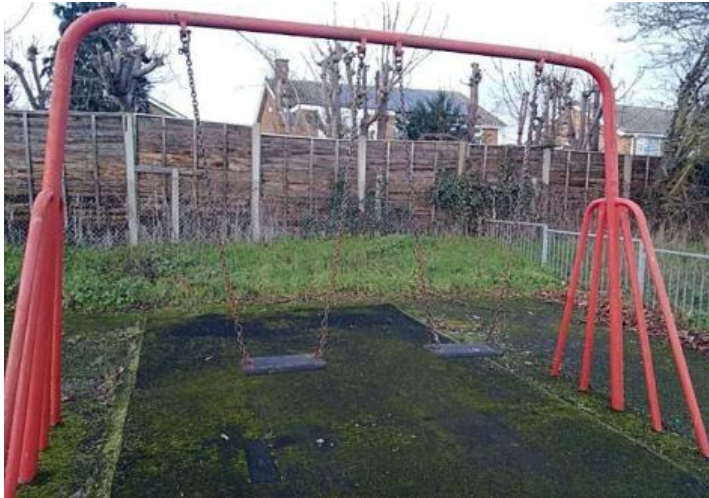
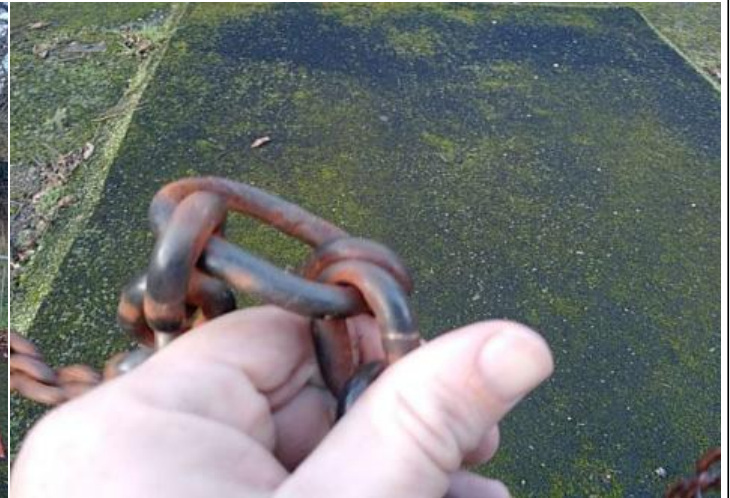
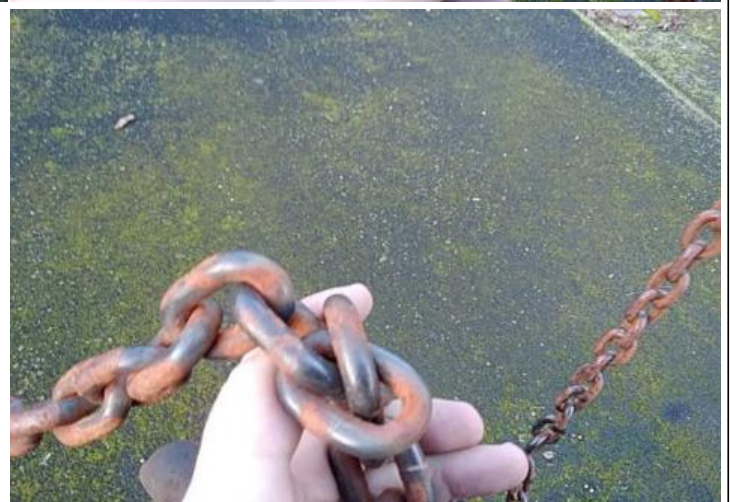
Finding: There is some notable evidence of chain wear

Action: Monitor for any further deterioration and replace when 40% worn

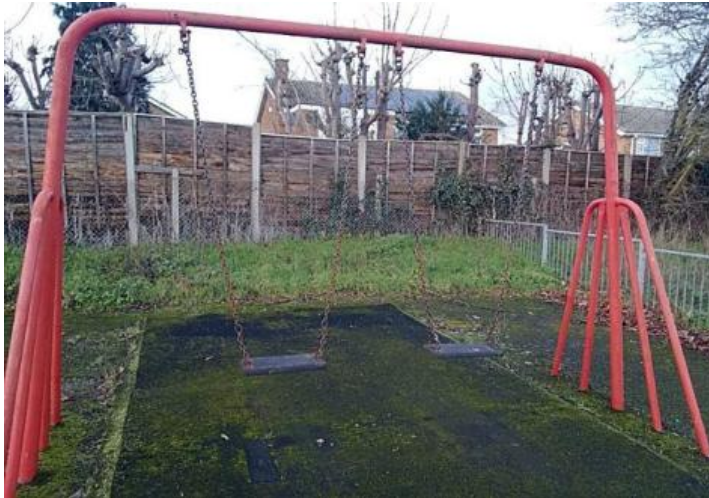
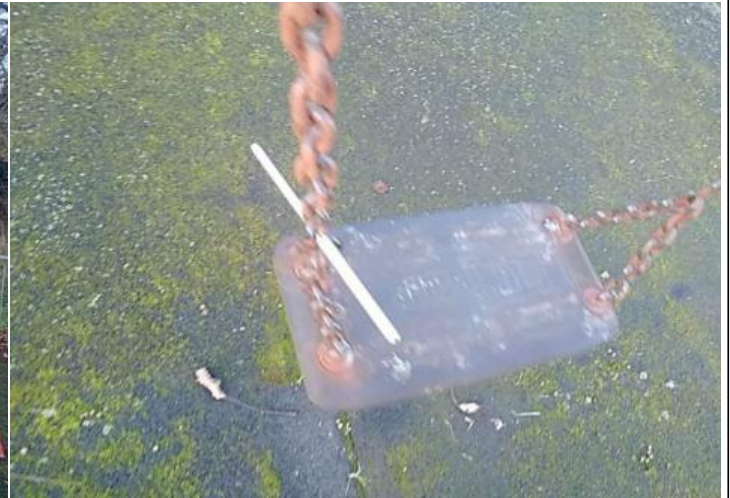
Finding: The chain openings are in excess of 8.6mm and do not meet the recommendations of BS EN 1176 Part 1

Action: Monitor - No remedial work recommended

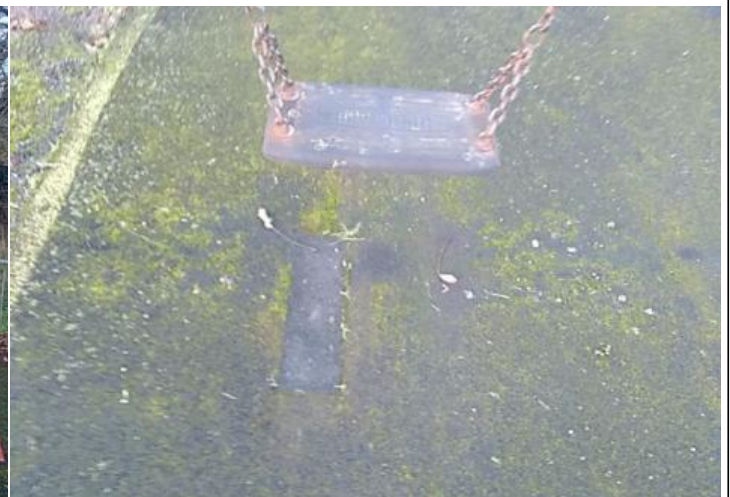
Finding: The surface has subsided in some areas

Action: Monitor for any further deterioration and repair as required

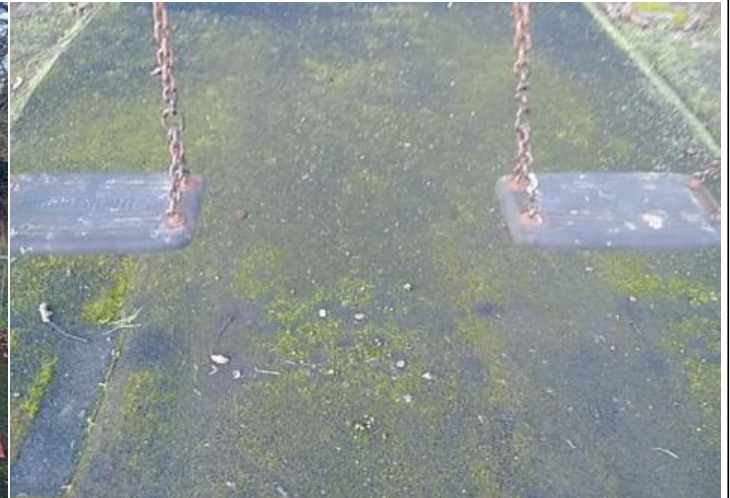
Finding: The safety surface around the area is beginning to wear

Action: Monitor for any further deterioration and repair as required

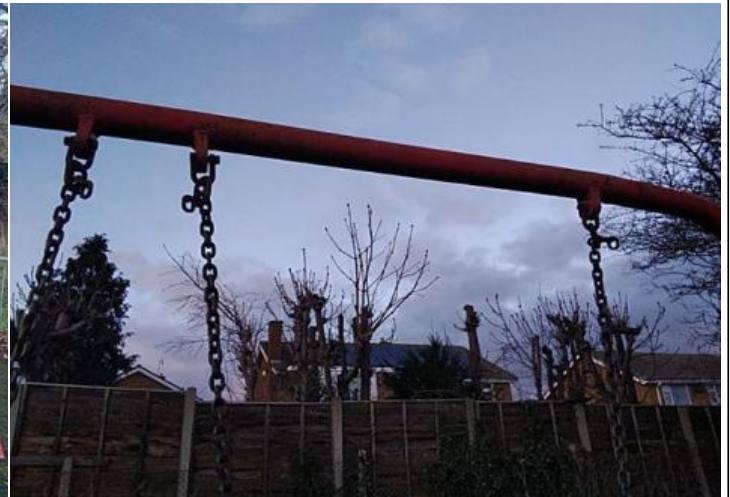
Finding: There is some wear to the shackles

Action: Monitor for any further deterioration and replace when 40% worn

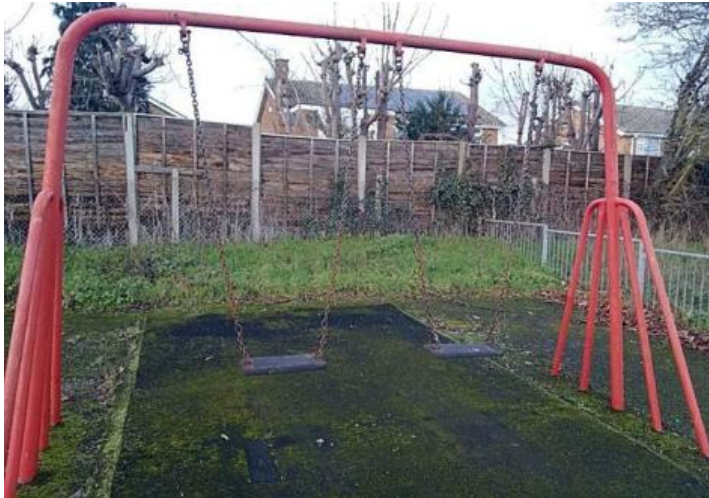
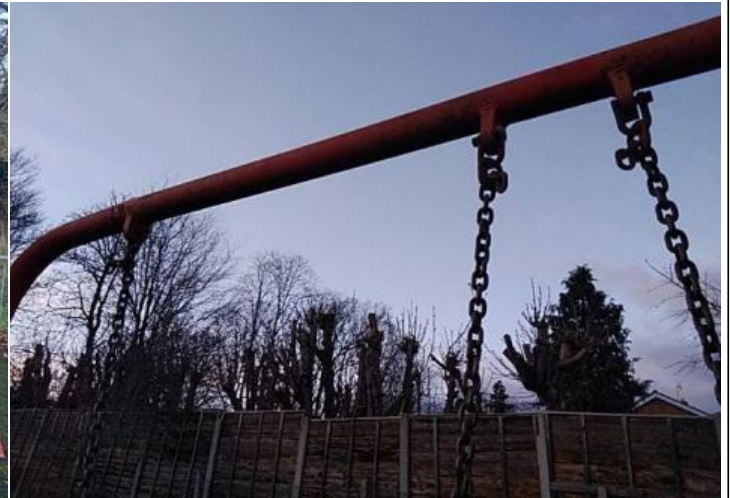
Finding: The bushes are worn or missing

Action: Replace worn or missing bushes

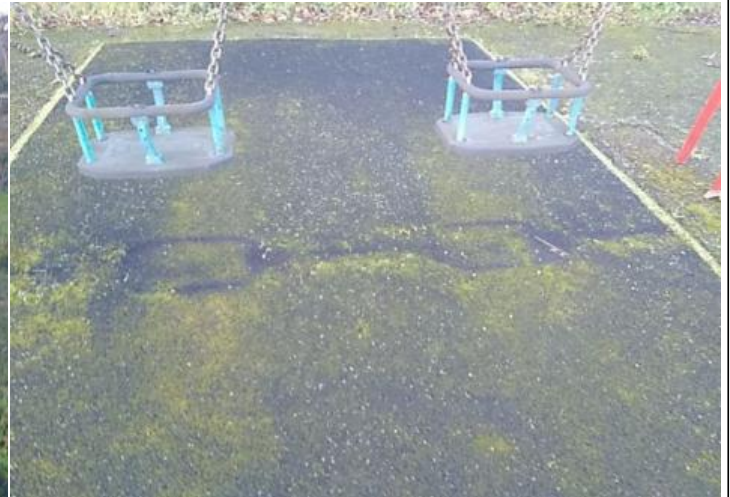
Finding: The safety surface around the area is beginning to wear

Action: Monitor for any further deterioration and repair as required

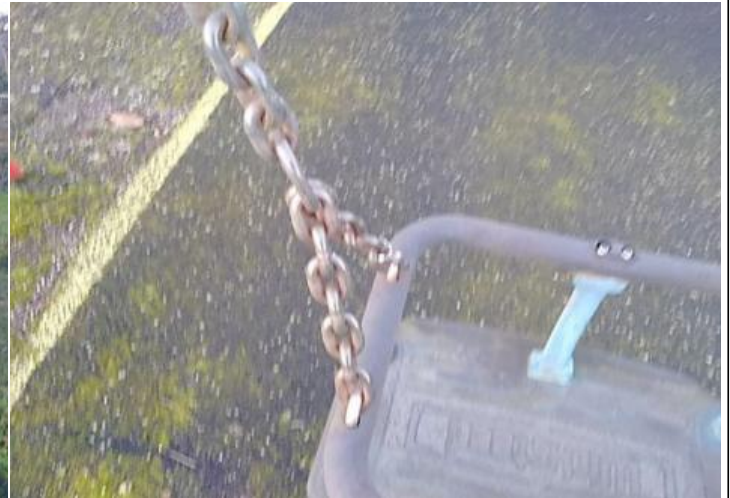
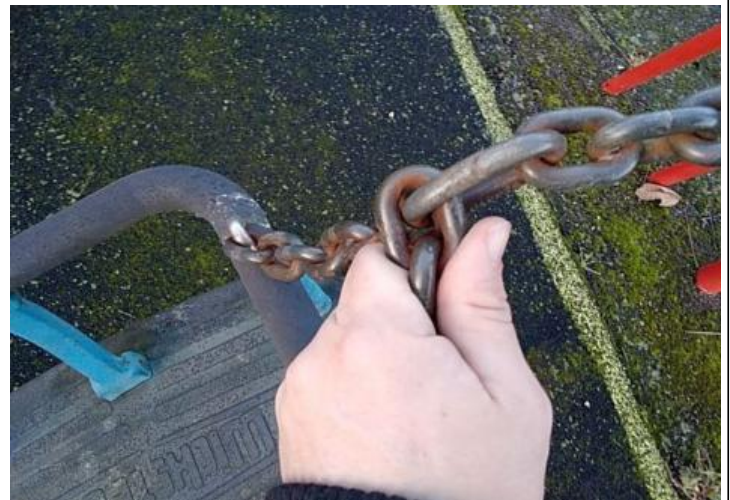
Finding: There is some notable evidence of chain wear

Action: Monitor for any further deterioration and replace when 40% worn

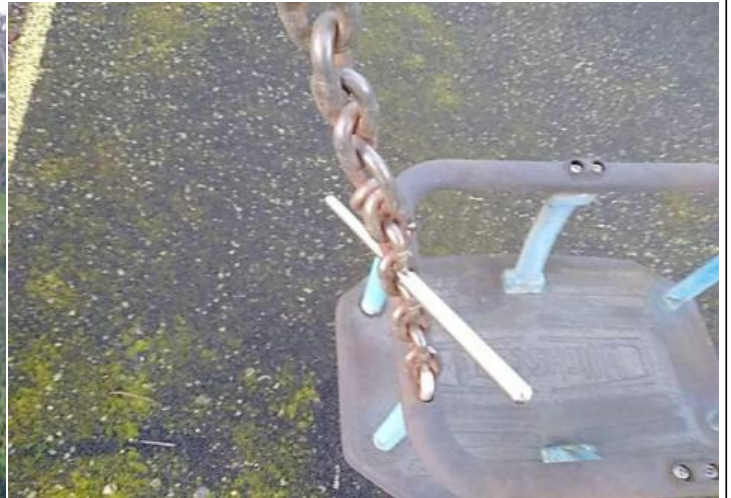
Finding: The chain openings are in excess of 8.6mm and do not meet the recommendations of BS EN 1176 Part 1

Action: Monitor - No remedial work recommended

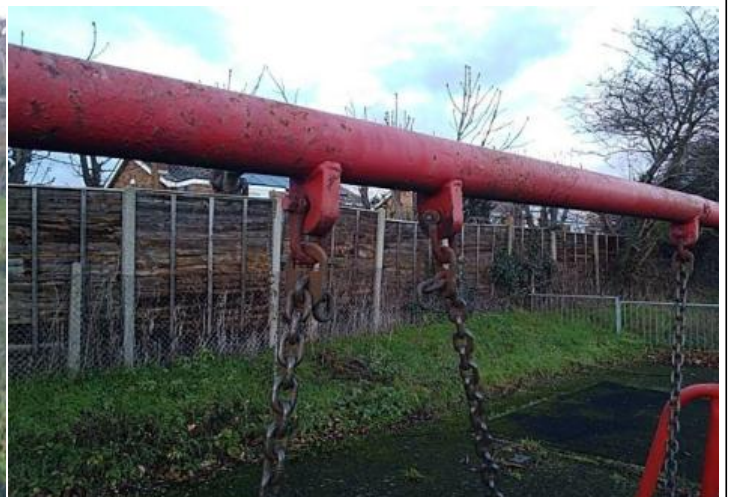
Finding: The bushes are worn or missing

Action: Replace worn or missing bushes

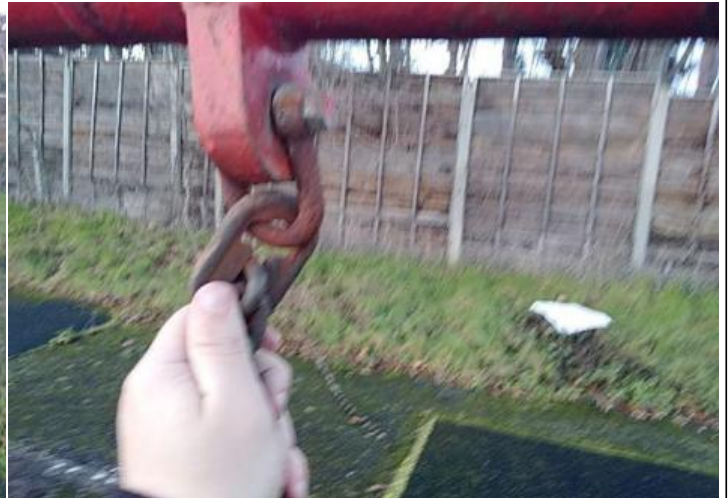
Finding: There is some wear to the shackles

Action: Monitor for any further deterioration and replace when 40% worn

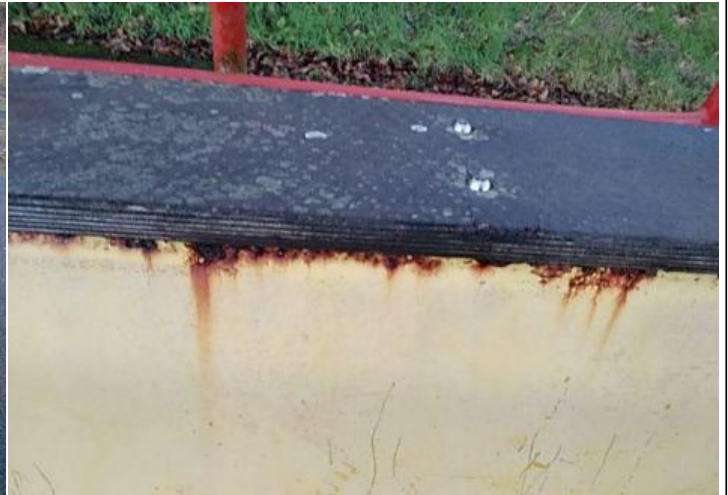
Finding: There is surface corrosion present on the item

Action: Consider treating the item

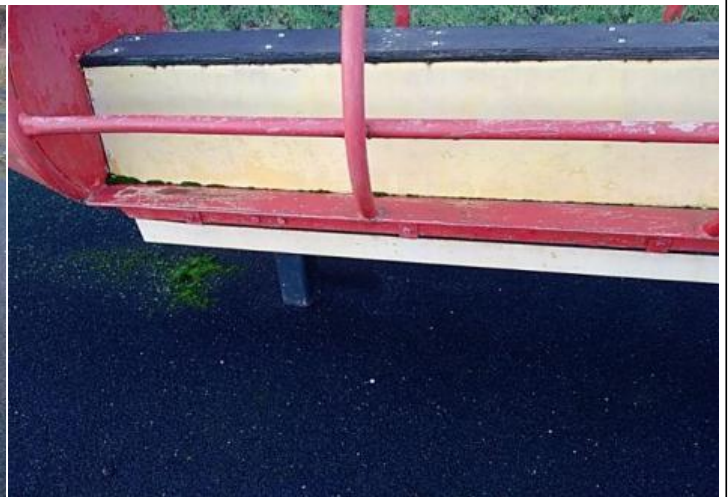
Finding: There is no gaiter protection for accessible moving parts (possible shear trap) as recommended in BS EN 1176 Part 1; 4.2.6 Moving Parts

Action: Monitor - No remedial work recommended

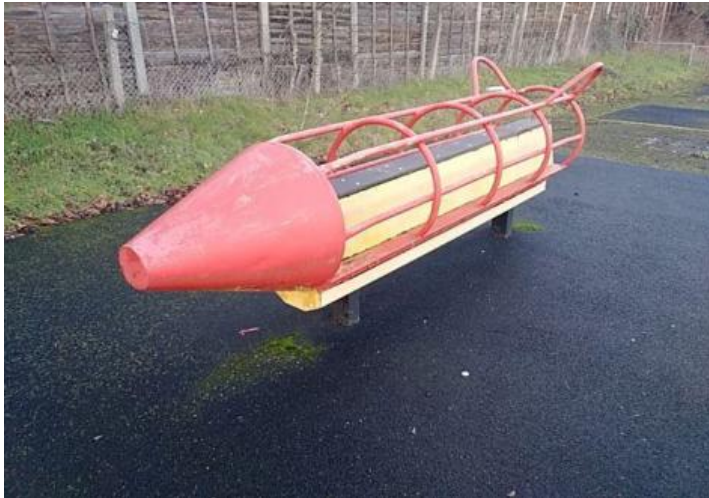
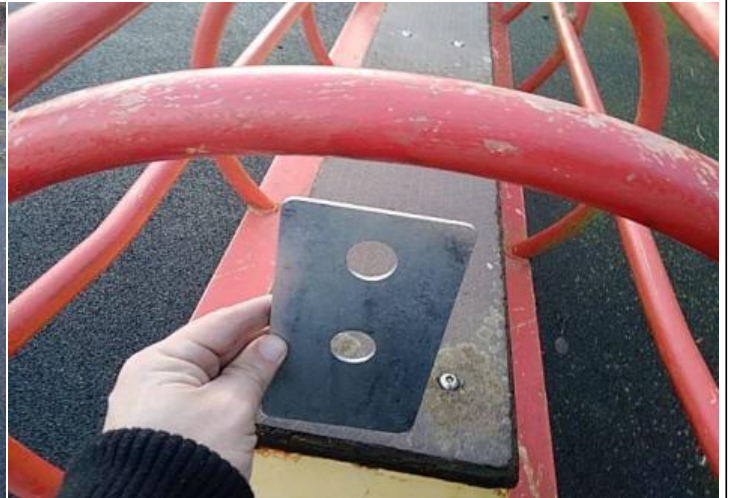
Finding: The item fails to meet the requirements of BS EN 1176 Part 1 4.2.7.2 for head and neck entrapment in the framework

Action: Monitor - No remedial work recommended

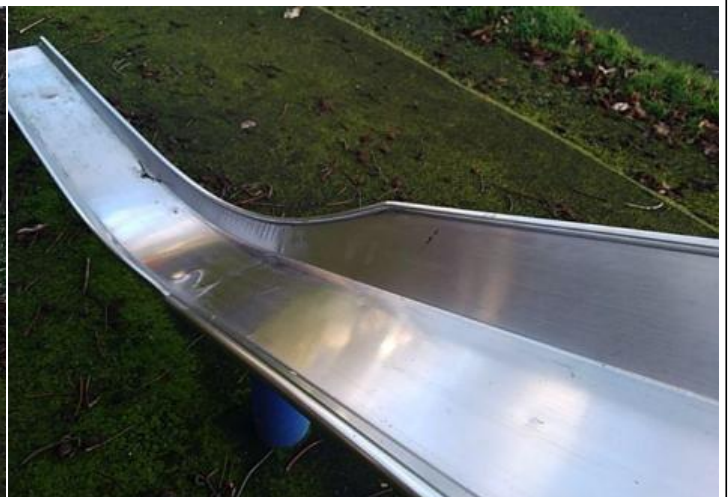
Finding: There are a number of dents in the slide surface

Action: Monitor for any further deterioration and repair as required

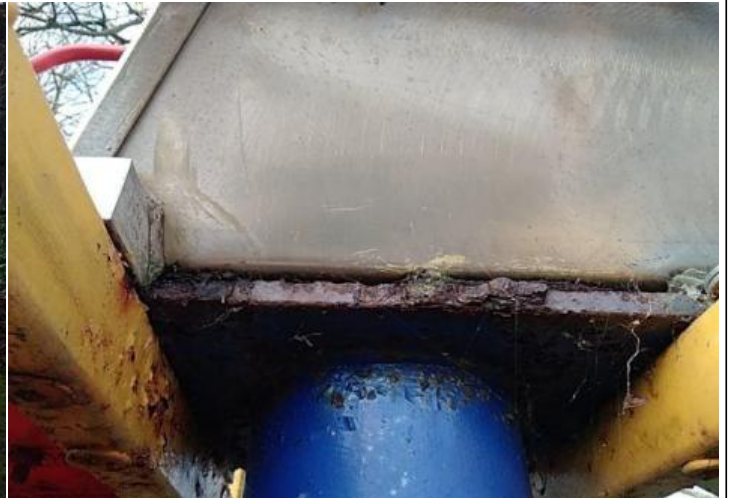
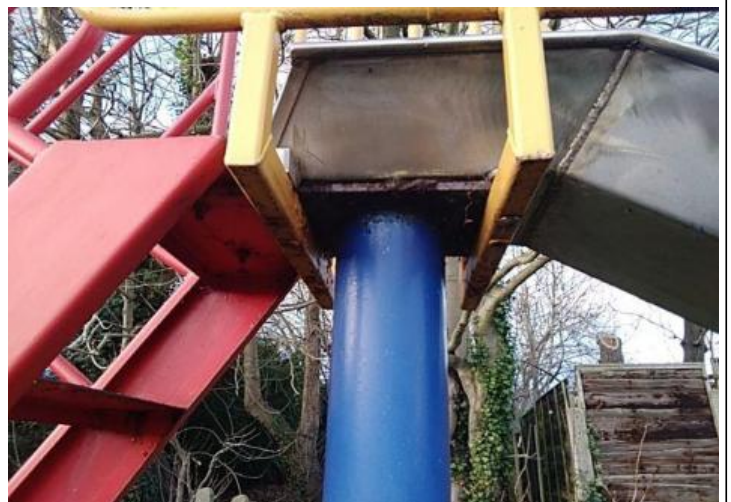
Finding: There is surface corrosion present on the item

Action: Consider treating the item

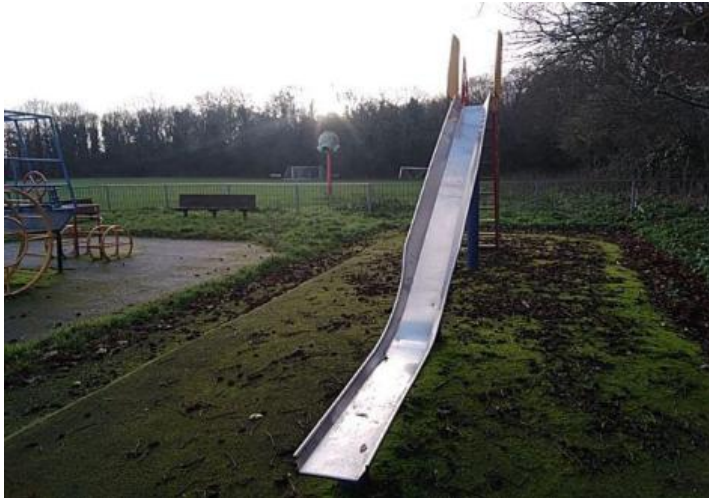
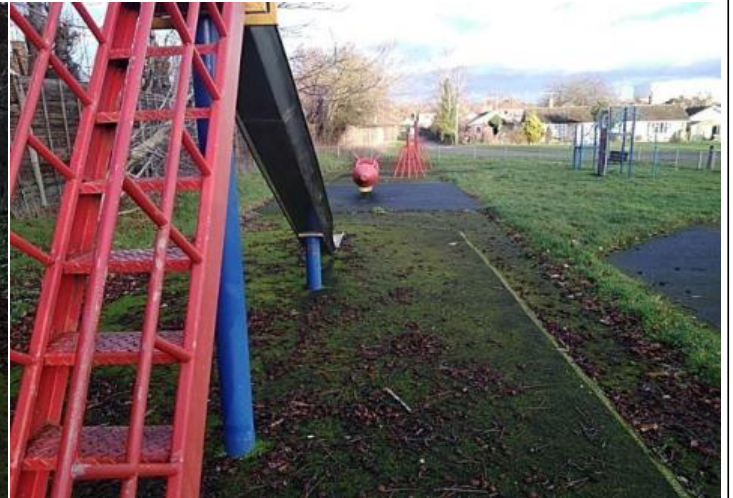
Finding: The surfacing dimensions are short and do not meet with the requirements of the current applicable standard

Action: Monitor - no remedial action recommended

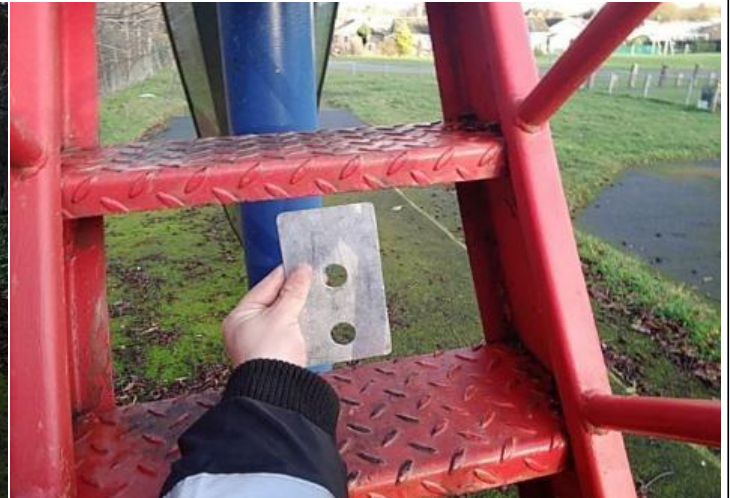
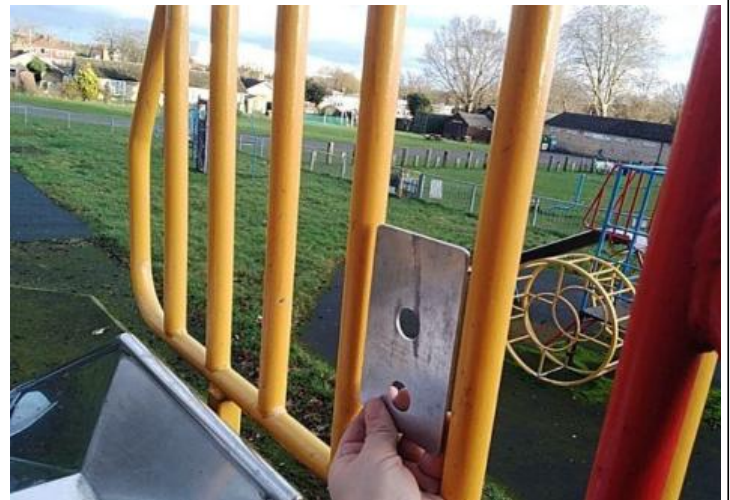
Finding: The item fails to meet the requirements of BS EN 1176 Part 1 4.2.7.2 head and neck entrapment in the barriers and/or steps

Action: Monitor - No remedial work recommended

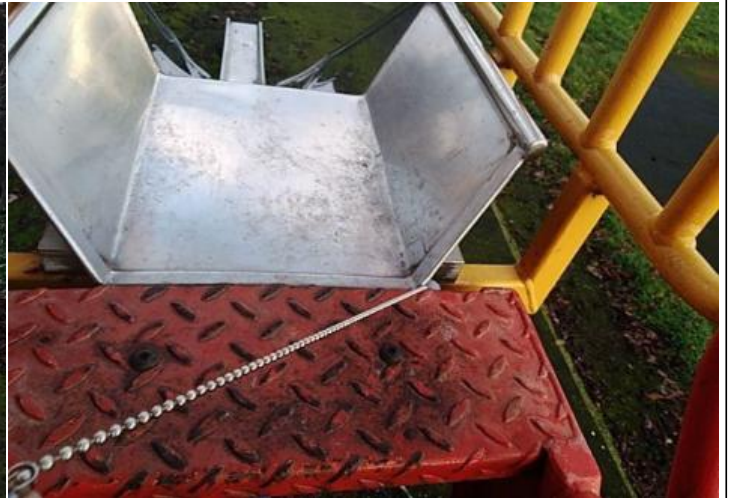
Finding: There is / are toggle entrapment/s present in contravention of the recommendations set out in BS EN 1176 Part 3

Action: Monitor - no remedial work recommended

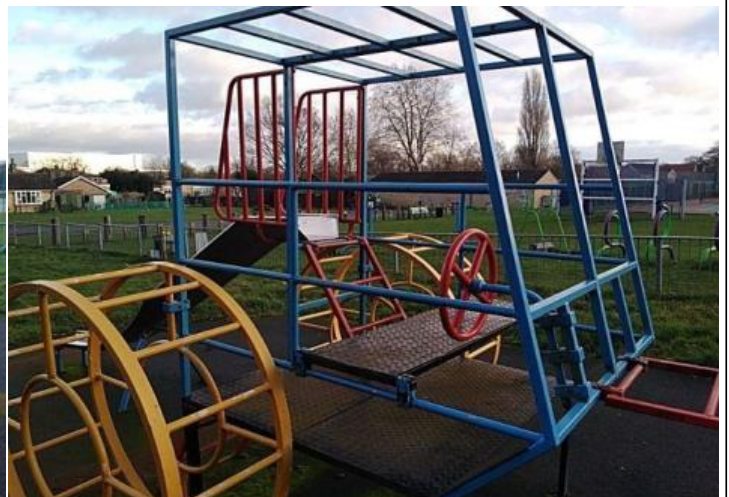
Finding: There are falls in excess of 600mm between adjacent components on the structure, in contravention of the recommendations set out in BS EN 1176 Part 1; 4.2.8.4

Action: Monitor - No remedial work recommended

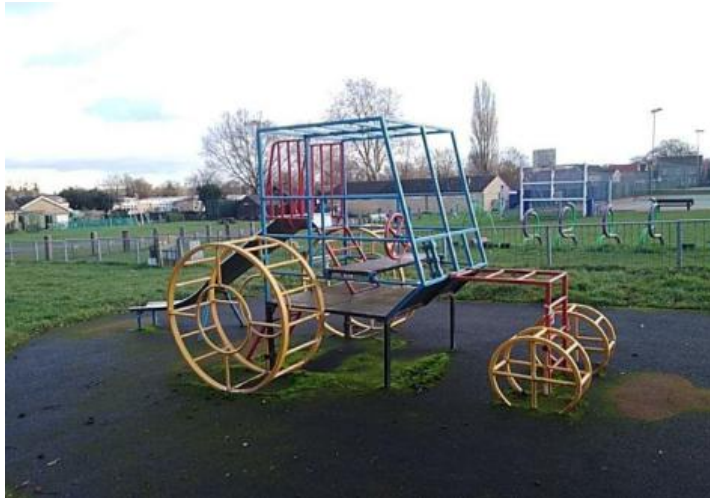
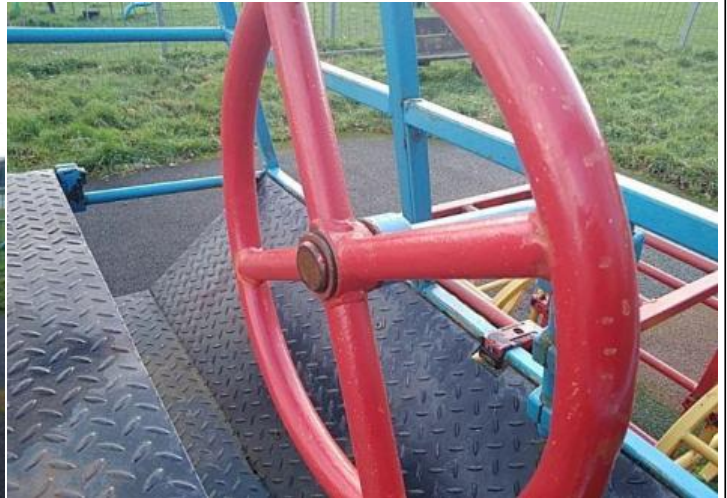
Finding: A number of fixing(s) have worked loose

Action: Secure all loose fixings

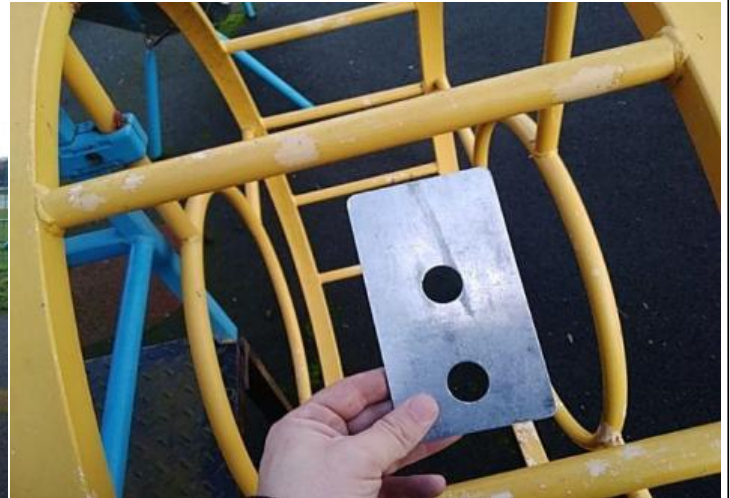
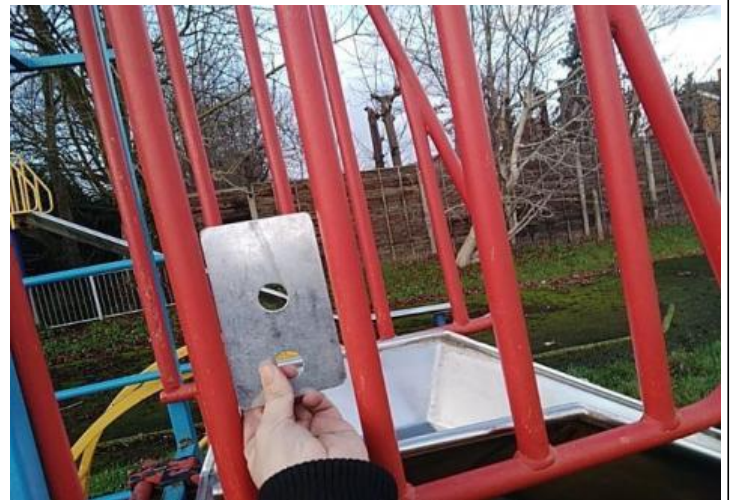
Finding: The item fails to meet the requirements of BS EN 1176 Part 1 4.2.7.2 for head and neck entrapment in the framework

Action: Monitor - No remedial work recommended

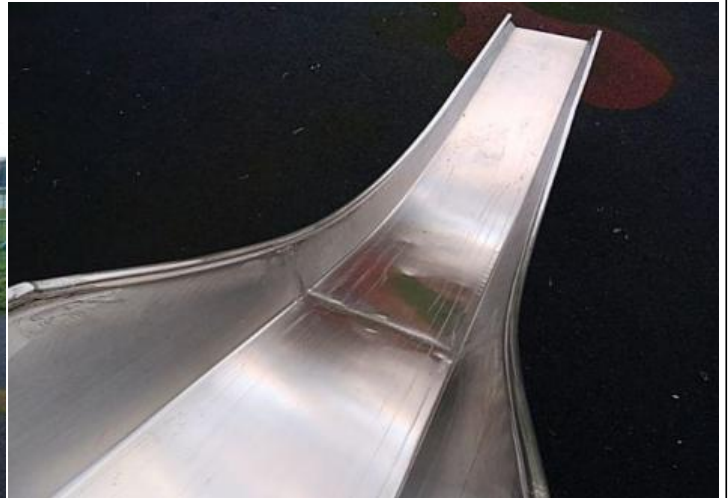
Finding: There are a number of dents in the slide surface

Action: Monitor for any further deterioration and repair as required

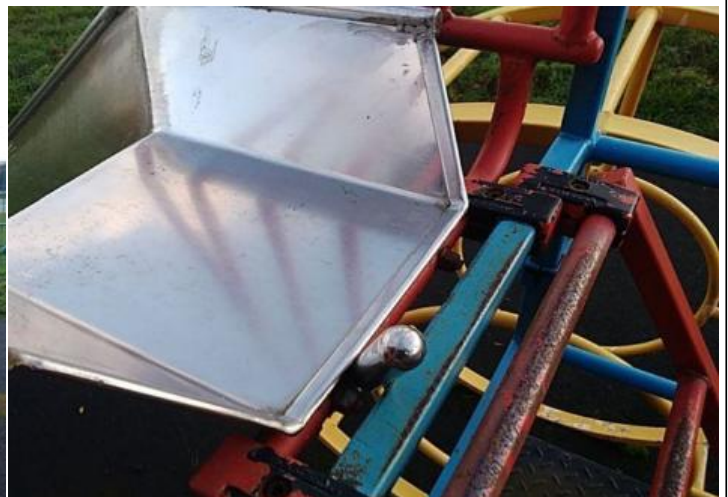
Finding: There is/are finger entrapment/s in the starting section of the slide and the item fails to meet the requirements of BS EN 1176 Part 1 4.2.7.6 Entrapment of fingers

Action: Monitor - No remedial work recommended

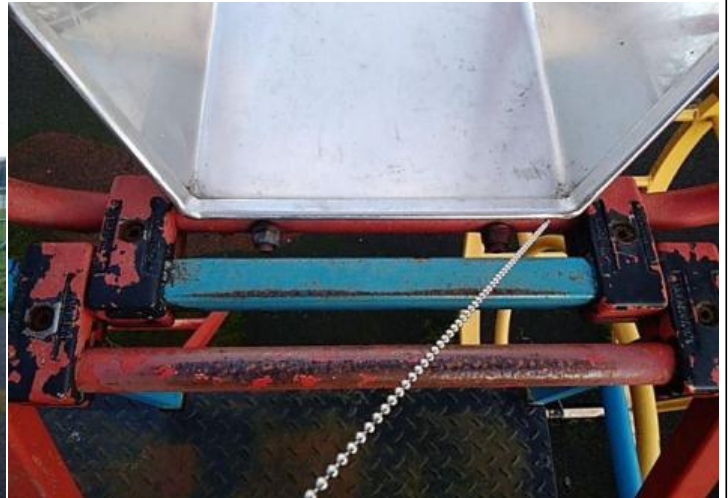
Finding: There is / are toggle entrapment/s present in contravention of the recommendations set out in BS EN 1176 Part 3

Action: Monitor - no remedial work recommended

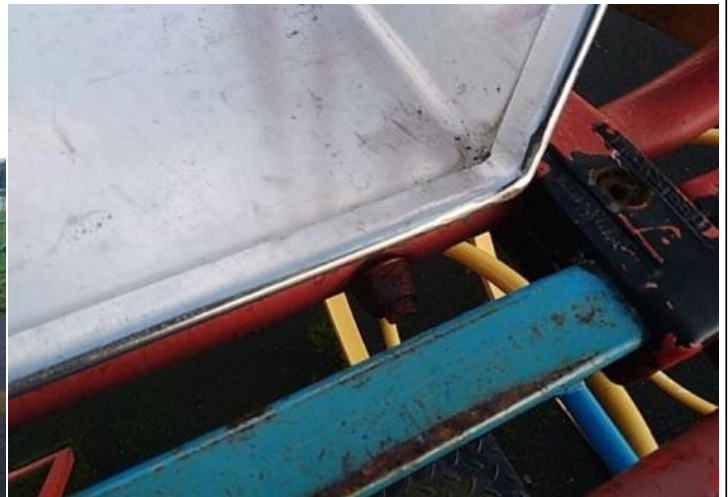
Finding: The fixings have corroded excessively

Action: Replace all corroded fixings

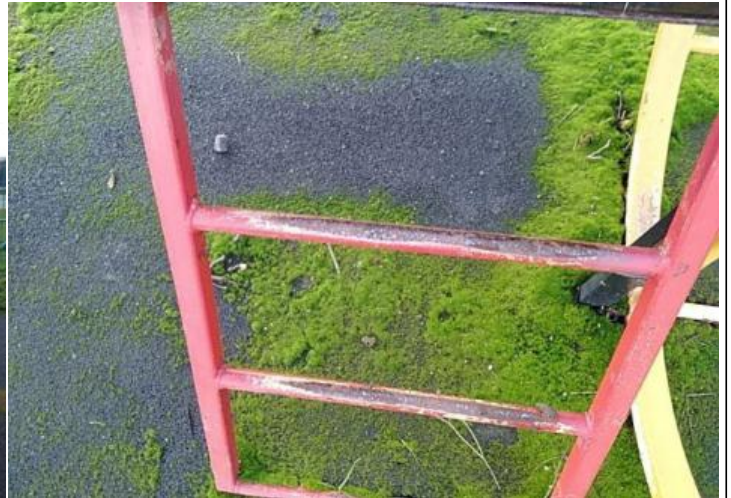
Finding: The paintwork on this item has been damaged or worn exposing the metal underneath which is rusting

Action: Treat any rusting components and repaint

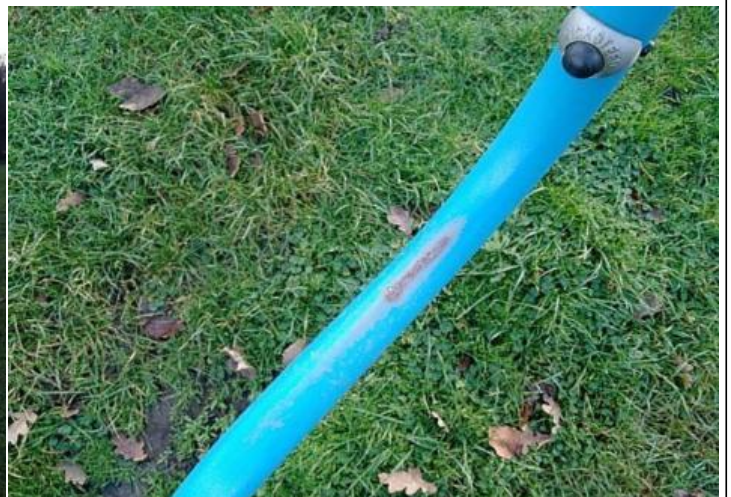
Finding: The paintwork on this item has been damaged or worn exposing the metal underneath which is rusting

Action: Treat any rusting components and repaint

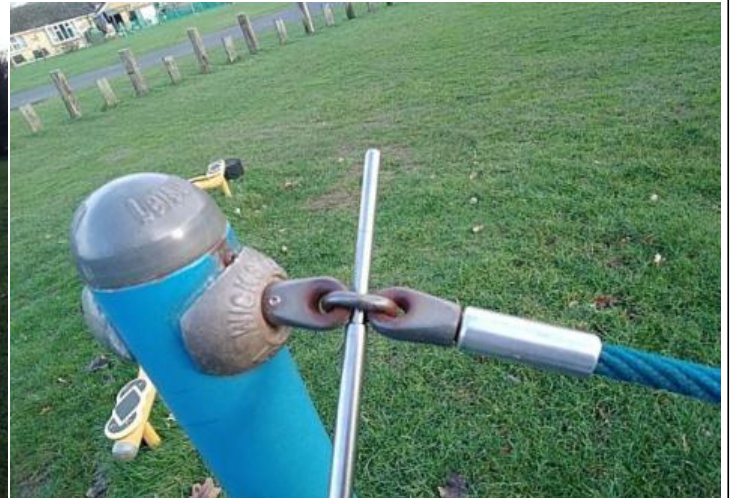
Finding: The chain openings are in excess of 8.6mm and do not meet the recommendations of BS EN 1176 Part 1

Action: Monitor - No remedial work recommended

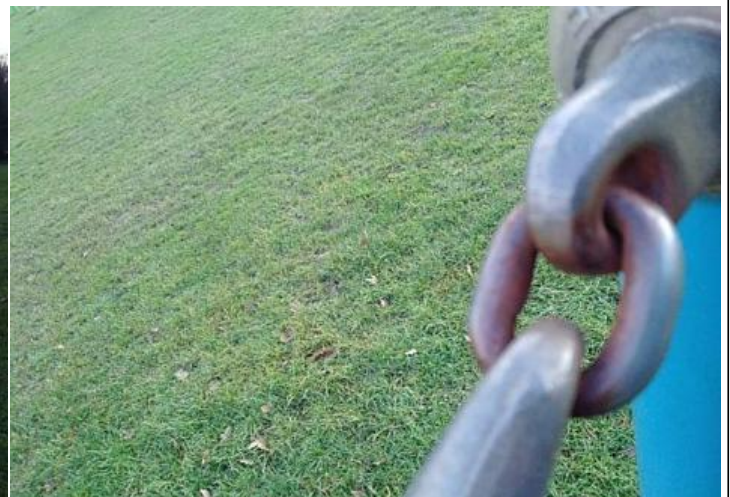
Finding: There is some notable evidence of chain wear

Action: Monitor for any further deterioration and replace when 40% worn

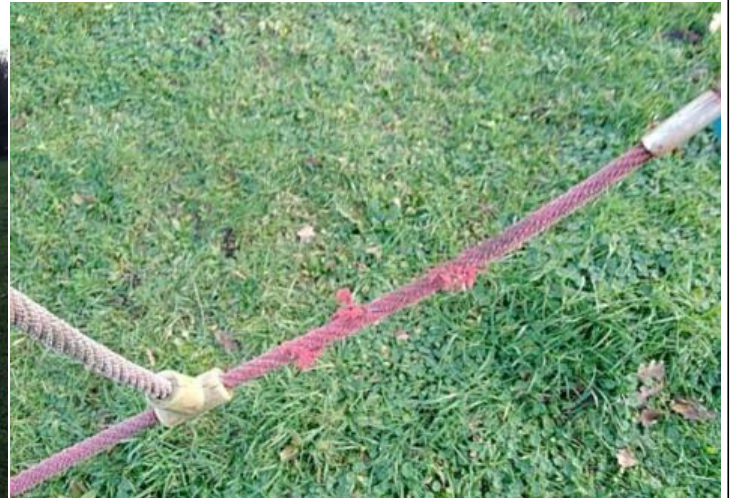
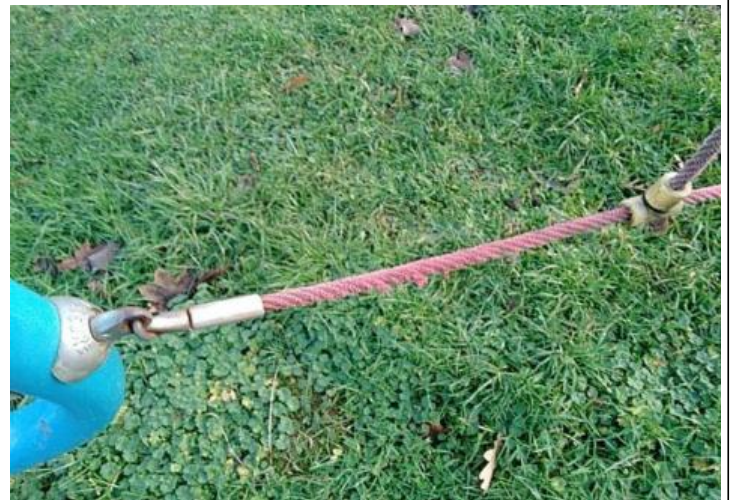
Finding: The ropes/nets are worn/damaged in places

Action: Monitor for any further deterioration and repair or replace as required
