the **play inspection** company

Annual Inspection

Babergh District Council

Sproughton Playing Fields

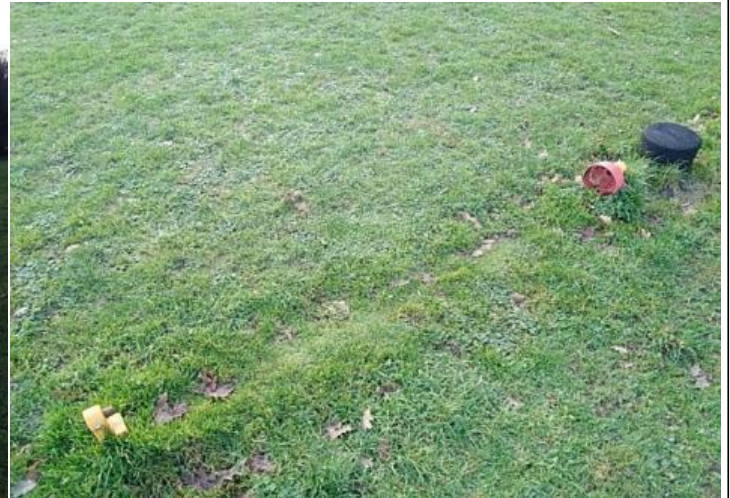
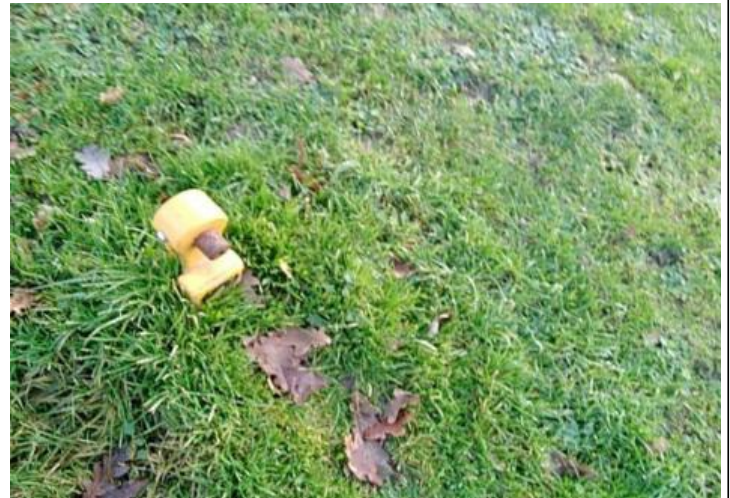
Finding: The rotating beam is missing from the activity trail **Action:** Replace missing component

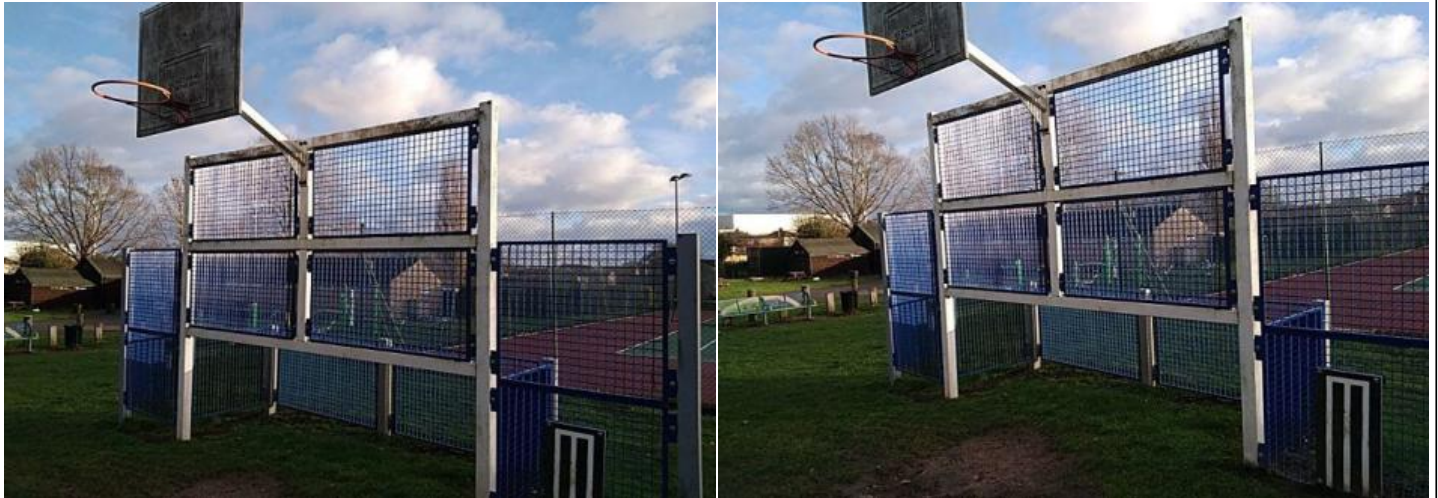
Finding: A clearly visible facility sign should be provided in a prominent position with the wording as detailed BS EN 15312- the equipment is not intended for children less than 3 years old- the warning - Do not climb on the framework or nets- the warning - Do not hang on the ring (if provided)- the warning - Do not wear rings or other jewellery- name and telephone number of the administrator- number to call in case of accident

Action: Provide signage to BS EN 15312

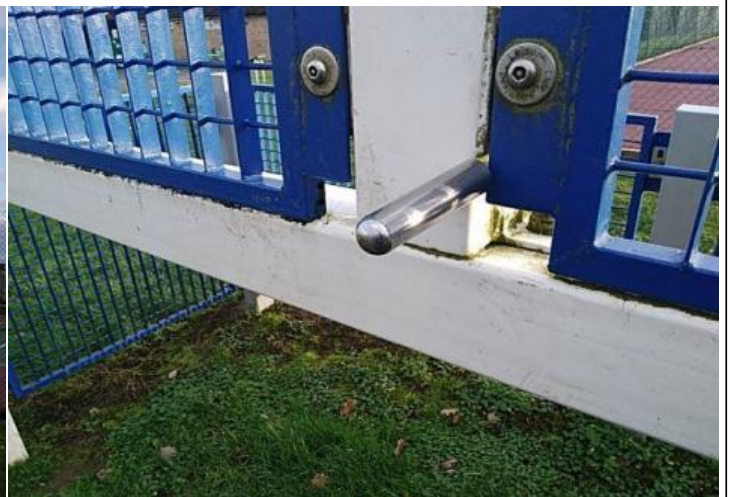
Finding: There is/are finger entrapments in the framework and the item fails to meet the requirements of BS EN 15312 Clause 4.4.2.2 Entrapment of fingers

Action: Monitor - No remedial work recommended

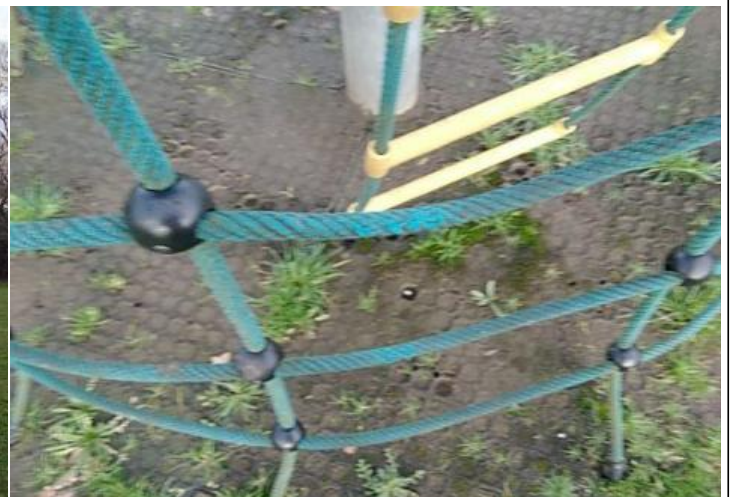
Finding: The ropes/nets are worn/damaged in places **Action:** Monitor for any further deterioration and repair or replace as required

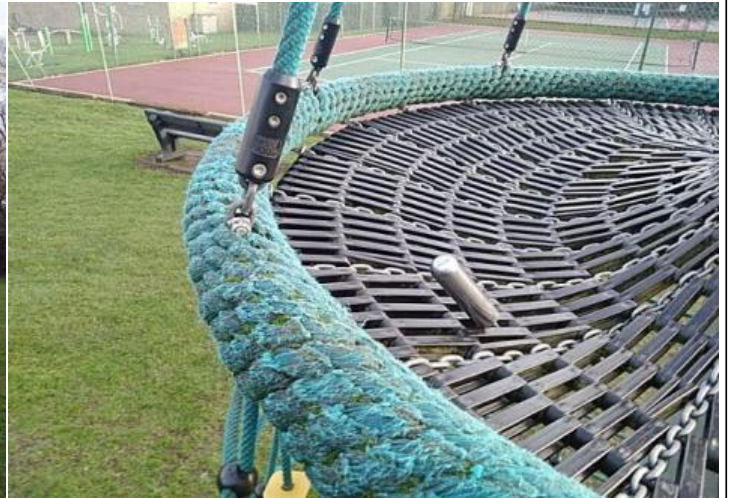
Finding: There is/are finger entrapment/s in the basket slots and the item fails to meet the requirements of BS EN 1176 Part 1 4.2.7.6 Entrapment of fingers
Action: Monitor - No remedial work recommended

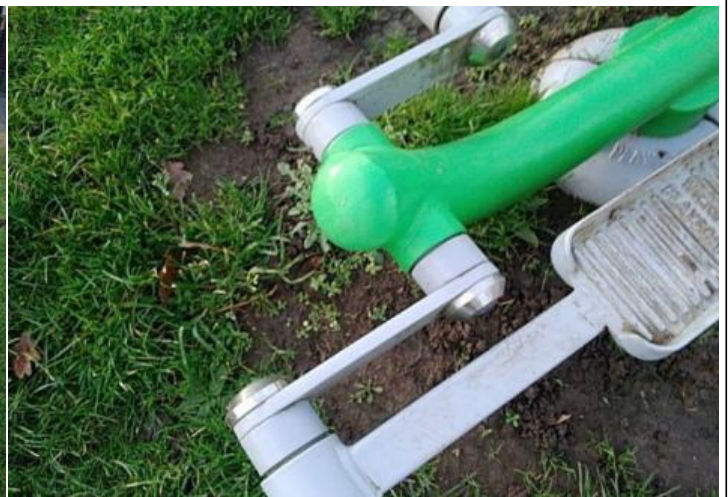
Finding: There are gaps between 8 and 60mm creating a potential crush/shear point in contravention of the requirements of BS EN 16630

Action: Monitor - No remedial work recommended

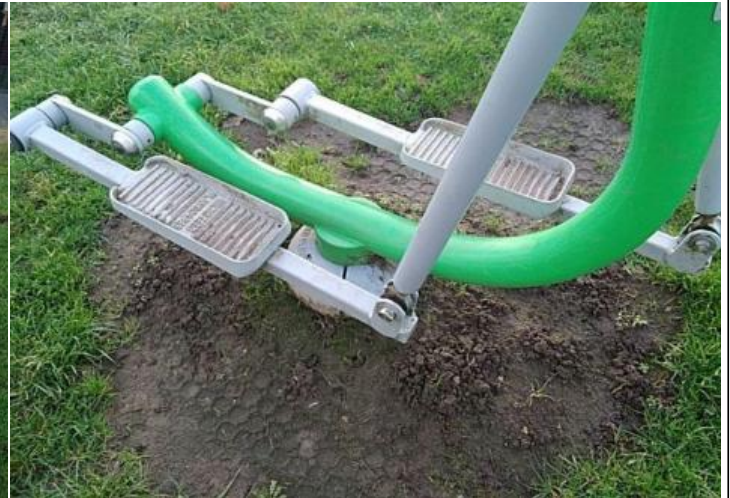
Finding: There is/are bolt cap covers missing or damaged on the item **Action:** Replace missing or damaged bolt cap covers

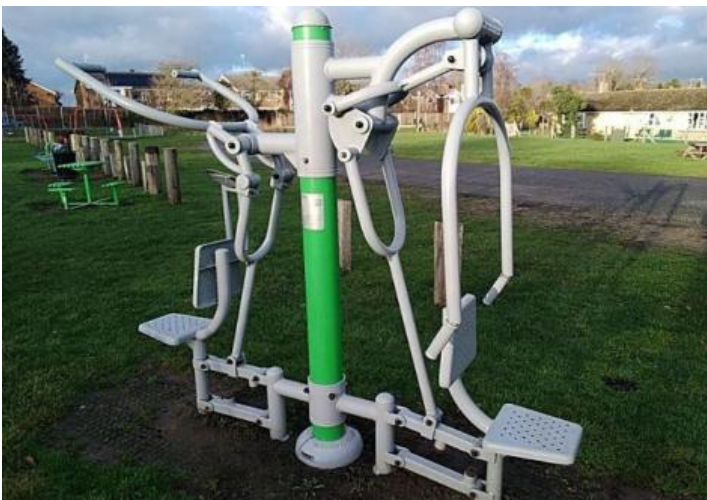
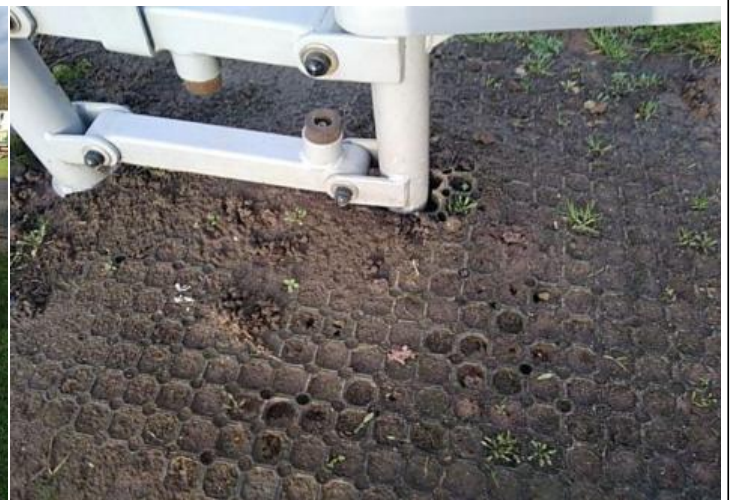
Finding: The distance between the underside of the item and the ground is less than the 110mm required by BS EN 16630 **Action:** Monitor - No remedial work recommended

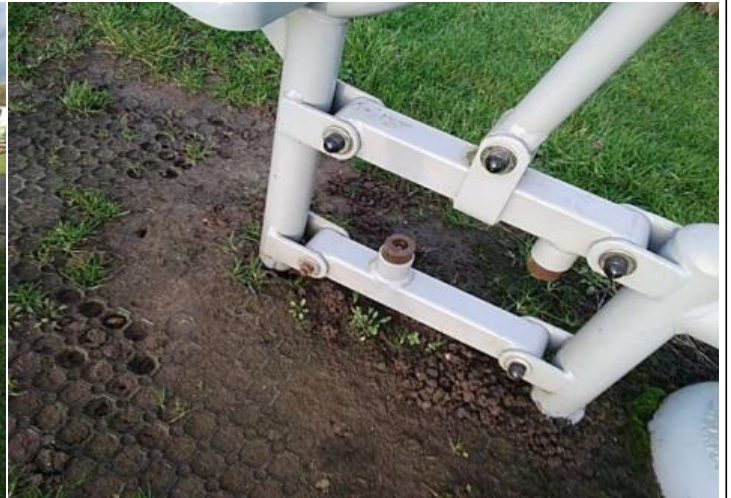
Finding: There is/are bolt cap covers missing or damaged on the item

Action: Replace missing or damaged bolt cap covers

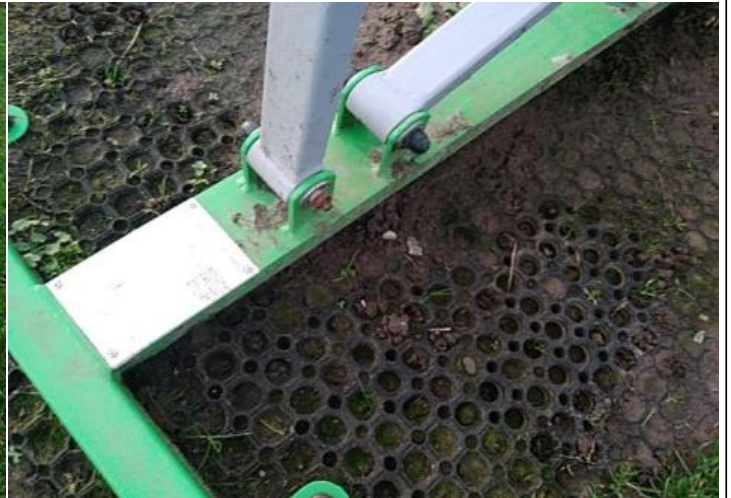
Finding: There is/are bolt cap covers missing or damaged on the item

Action: Replace missing or damaged bolt cap covers

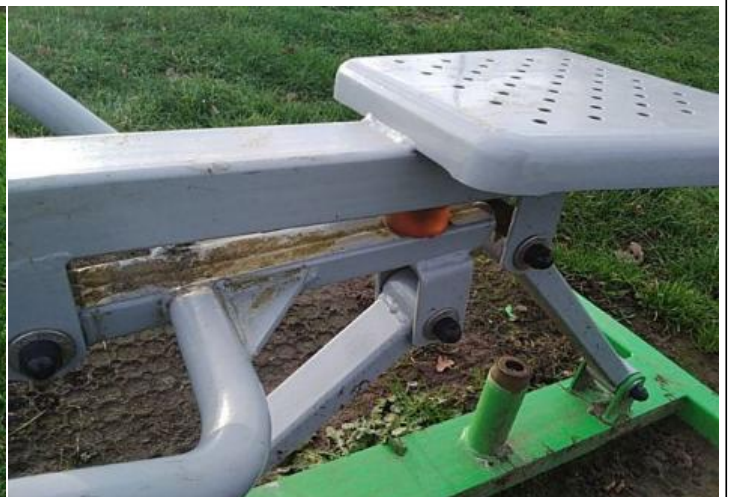
Finding: There are gaps between 8 and 60mm creating a potential crush/shear point in contravention of the requirements of BS EN 16630

Action: Monitor - No remedial work recommended
