the **play inspection** company

Annual Inspection

Babergh District Council

Sproughton Playing Fields

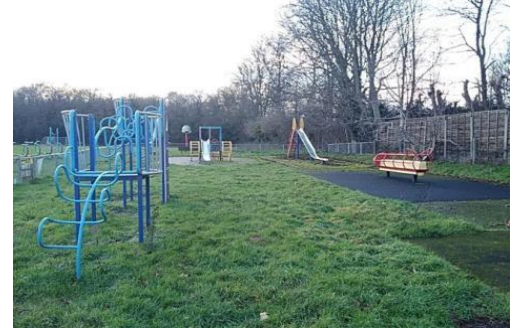
Item: Site General
Manufacturer: Owner/Operator
Surface Type: N/A
Item Quantity: 1
Equipment Compliance: N/A
Surface Area Compliance: N/A

The grass mats are silted up, the soil is compacted and the area will become very slippery when the soil is wet. - Reinstate as required

The surface is lifting at the edges and creating trip points - Repair perimeter of surfacing to remove trip points

There are significant gaps (over 30mm) between the surface and the edging or between the joints in the surface; these are large enough for a small foot to enter - Repair surfacing

There is algae, silt or moss growth on the surface resulting in slippery conditions - Clean and treat appropriately

The grass is overgrown within the play area and may hide hazards - Reduce the length of grass to an acceptable height and maintain

The rotating beam has been removed from the activity trail and has been left in the play area - Repair damaged section of the activity trail

There is damage to the tarmac surface - Repair the damaged areas of surfacing

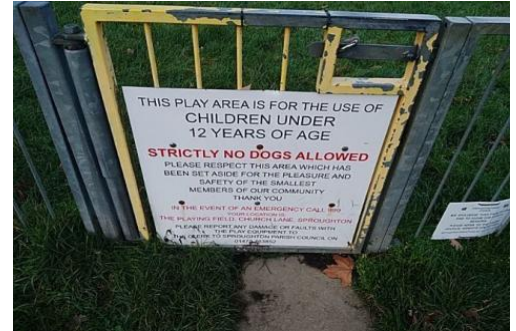
Item: Sign
Manufacturer: Owner/Operator
Surface Type: N/A
Item Quantity: 1
Equipment Compliance: N/A
Surface Area Compliance: N/A

It is recommended that signage, with information including the site address, contact information for maintenance issues and emergency contact details are provided for the facility - Provide in accordance with the recommendations

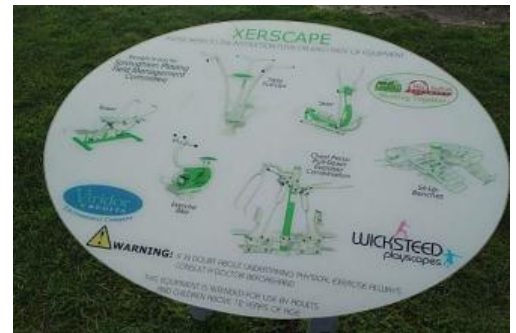
Item: Sign
Manufacturer: Wicksteed Playgrounds
Surface Type: Grass
Item Quantity: 1
Equipment Compliance: N/A
Surface Area Compliance: N/A

This item is satisfactory - no work required -

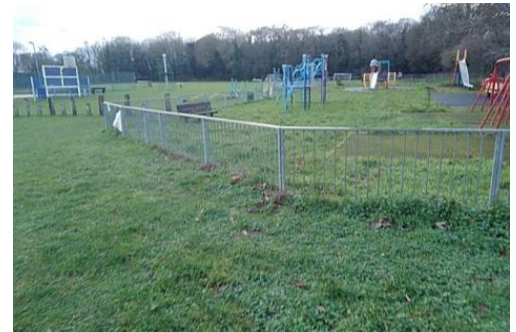
Item: Fencing - Flat Top
Manufacturer: Not Identified
Surface Type: Grass
Item Quantity: 1
Equipment Compliance: N/A
Surface Area Compliance: N/A

There is some damage to the fence sections - Monitor for any further deterioration and repair as required

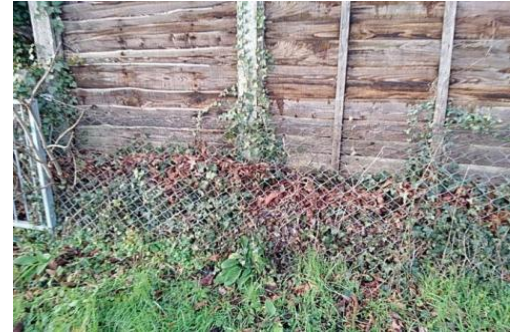
Item: Fence - Chainlink
Manufacturer: Not Identified
Surface Type: Grass
Item Quantity: 1
Equipment Compliance: N/A
Surface Area Compliance: N/A

The fence is damaged in places - Repair or replace all affected sections

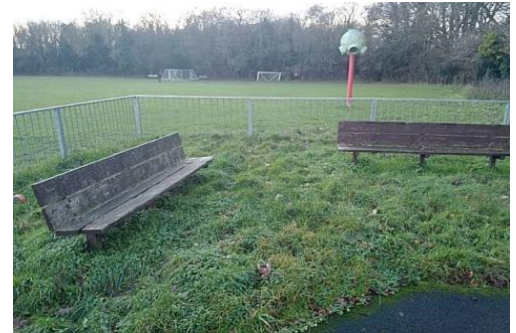
Item: Bench
Manufacturer: Not Identified
Surface Type: Grass
Item Quantity: 1
Equipment Compliance: N/A
Surface Area Compliance: N/A

There are areas or parts of the timber on the structure that have rotted - Replace all affected timbers

The paintwork on this item has been damaged or worn exposing the metal underneath which is rusting - Treat any rusting components and repaint

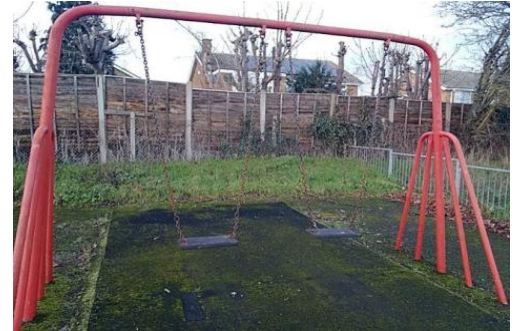
Item: 1 Bay 2 Seat (Flat)
Manufacturer: Wicksteed Playgrounds
Surface Type: Wet Pour
Item Quantity: 1
Equipment Compliance: No
Surface Area Compliance: Yes

There is some notable evidence of chain wear - Monitor for any further deterioration and replace when 40% worn

The chain openings are in excess of 8.6mm and do not meet the recommendations of BS EN 1176 Part 1 - Monitor - No remedial work recommended

The surface has subsided in some areas - Monitor for any further deterioration and repair as required

The safety surface around the area is beginning to wear - Monitor for any further deterioration and repair as required

There is some wear to the shackles - Monitor for any further deterioration and replace when 40% worn

The bushes are worn or missing - Replace worn or missing bushes

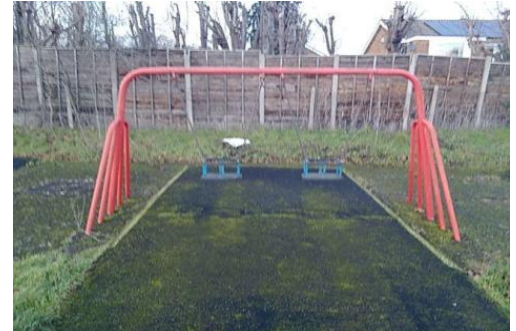
Item: 1 Bay 2 Seat (Cradle)
Manufacturer: Wicksteed Playgrounds
Surface Type: Wet Pour
Item Quantity: 1
Equipment Compliance: No
Surface Area Compliance: Yes

The safety surface around the area is beginning to wear - Monitor for any further deterioration and repair as required

There is some notable evidence of chain wear - Monitor for any further deterioration and replace when 40% worn

The chain openings are in excess of 8.6mm and do not meet the recommendations of BS EN 1176 Part 1 - Monitor - No remedial work recommended

The bushes are worn or missing - Replace worn or missing bushes

There is some wear to the shackles - Monitor for any further deterioration and replace when 40% worn

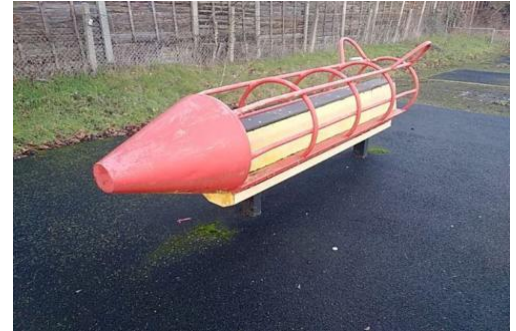
Item: Rocking Rocket
Manufacturer: Wicksteed Playgrounds
Surface Type: Wet Pour
Item Quantity: 1
Equipment Compliance: No
Surface Area Compliance: Yes

There is surface corrosion present on the item - Consider treating the item

There is no gaiter protection for accessible moving parts (possible shear trap) as recommended in BS EN 1176 Part 1; 4.2.6 Moving Parts - Monitor - No remedial work recommended

The item fails to meet the requirements of BS EN 1176 Part 1 4.2.7.2 for head and neck entrapment in the framework - Monitor - No remedial work recommended

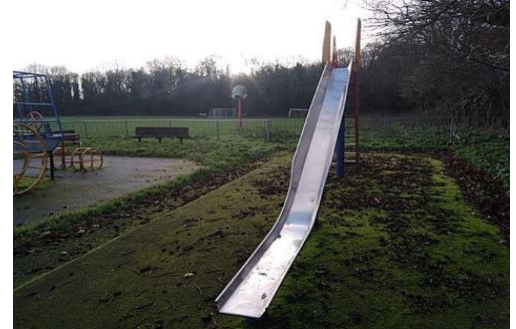
Item: Free Standing Slide
Manufacturer: Wicksteed Playgrounds
Surface Type: Wet Pour
Item Quantity: 1
Equipment Compliance: No
Surface Area Compliance: No

The tree canopy overhangs the equipment and is less than 2.0m away - Lift tree canopy to ensure a minimum clearance of 2.0m from the equipment

There are a number of dents in the slide surface - Monitor for any further deterioration and repair as required

There is surface corrosion present on the item - Consider treating the item

The surfacing dimensions are short and do not meet with the requirements of the current applicable standard - Monitor - no remedial action recommended

There is / are toggle entrapment/s present in contravention of the recommendations set out in BS EN 1176 Part 3 - Monitor - no remedial work recommended

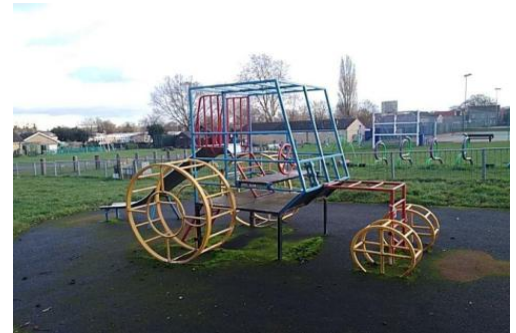
Item: Tractor
Manufacturer: Wicksteed Playgrounds
Surface Type: Wet Pour
Item Quantity: 1
Equipment Compliance: No
Surface Area Compliance: Yes

There are falls in excess of 600mm between adjacent components on the structure, in contravention of the recommendations set out in BS EN 1176 Part 1; 4.2.8.4 - Monitor - No remedial work recommended

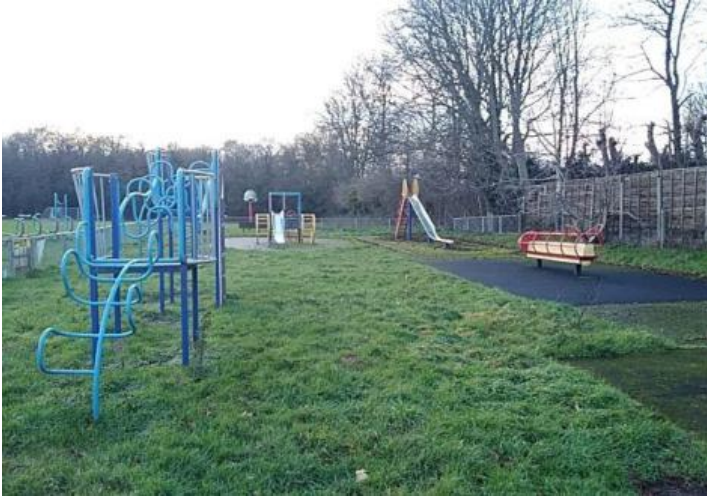
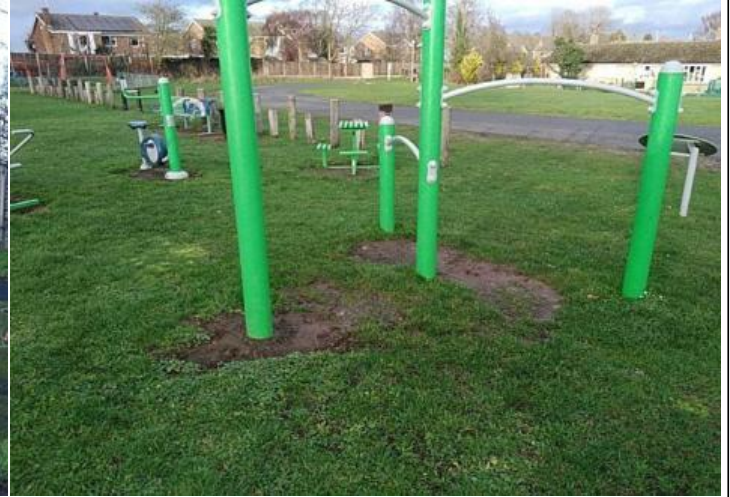
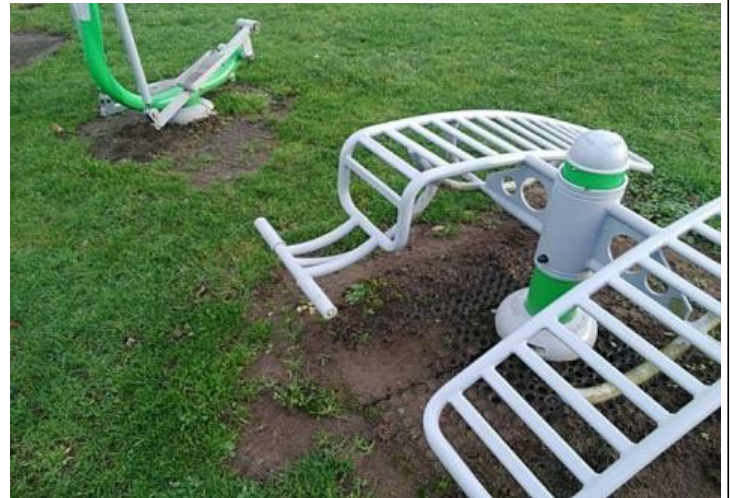
Item: Ancillary Items - Site General
Manufacturer: Owner/Operator

Finding: The grass mats are silted up, the soil is compacted and the area will become very slippery when the soil is wet. **Action:** Reinstate as required

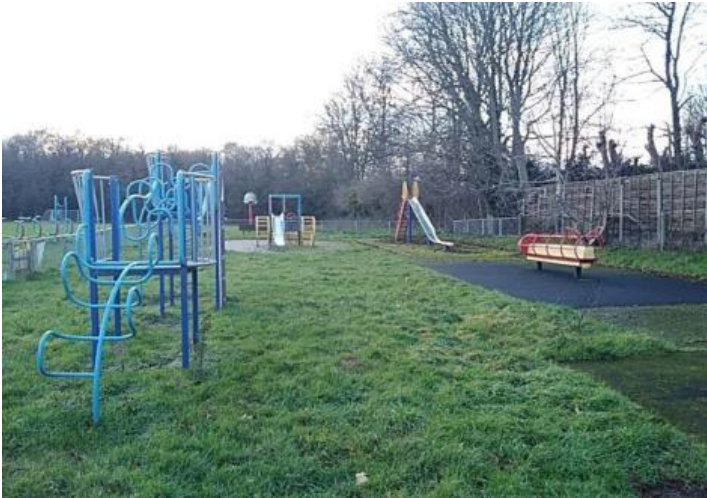
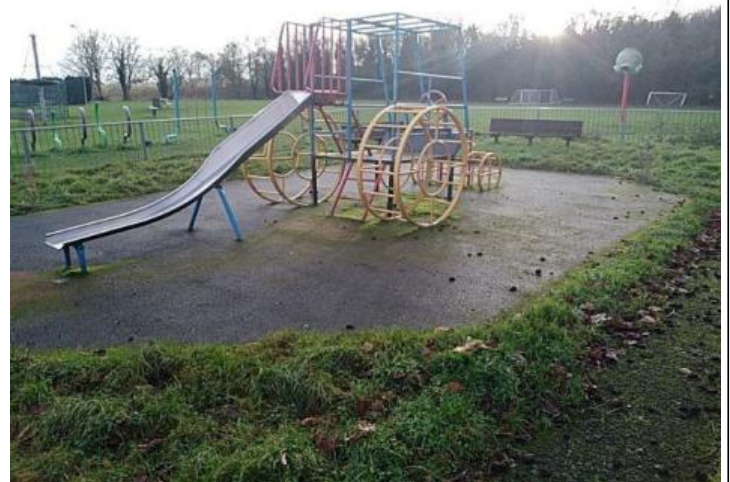
Item: Ancillary Items - Site General
Manufacturer: Owner/Operator

Finding: There is algae, silt or moss growth on the surface resulting in slippery conditions

Action: Clean and treat appropriately

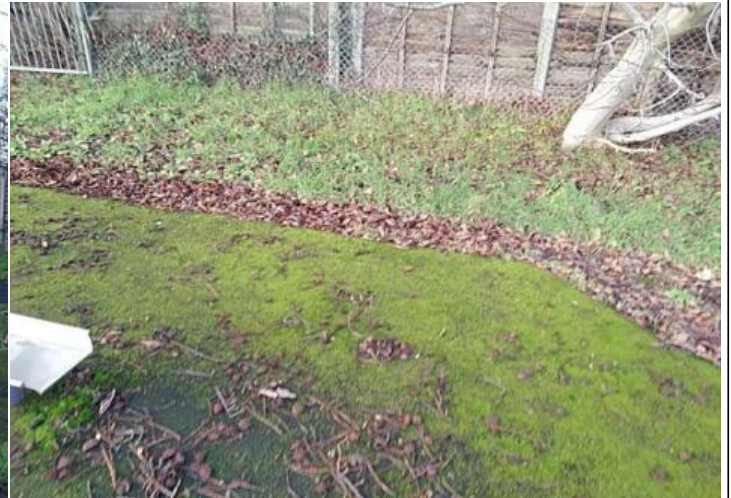
Item: Ancillary Items - Site General
Manufacturer: Owner/Operator

Finding: There is some tree debris on the surfacing

Action: Remove and maintain

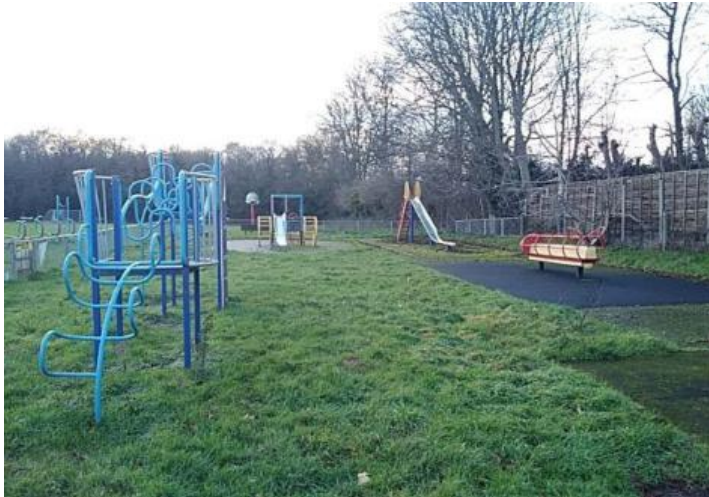
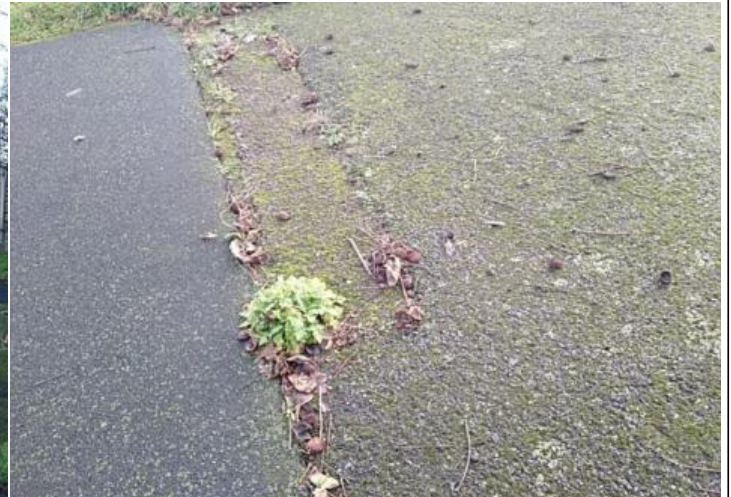
Item: Ancillary Items - Site General
Manufacturer: Owner/Operator

Finding: There is weed / vegetation growth on, between, or around the edges of the surfacing

Action: Remove weed / vegetation growth

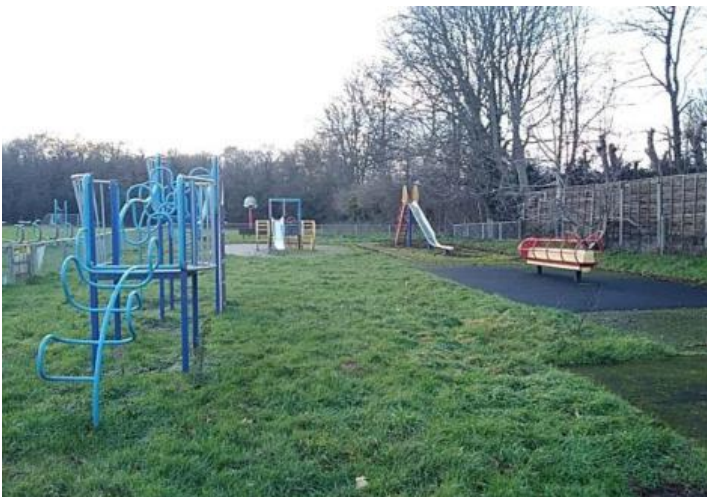
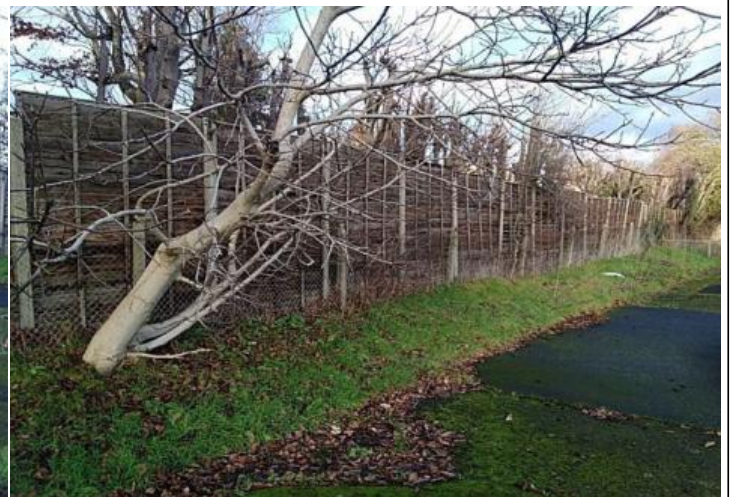
Item: Ancillary Items - Site General
Manufacturer: Owner/Operator

Finding: The adjacent foliage is overhanging into the playing area

Action: Cut back and maintain

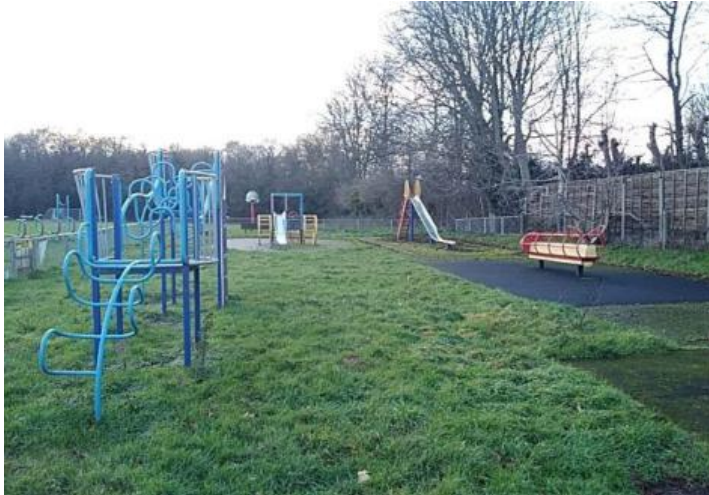
Item: Ancillary Items - Site General
Manufacturer: Owner/Operator

Finding: The rotating beam has been removed from the activity trail and has been left in the play area

Action: Repair damaged section of the activity trail

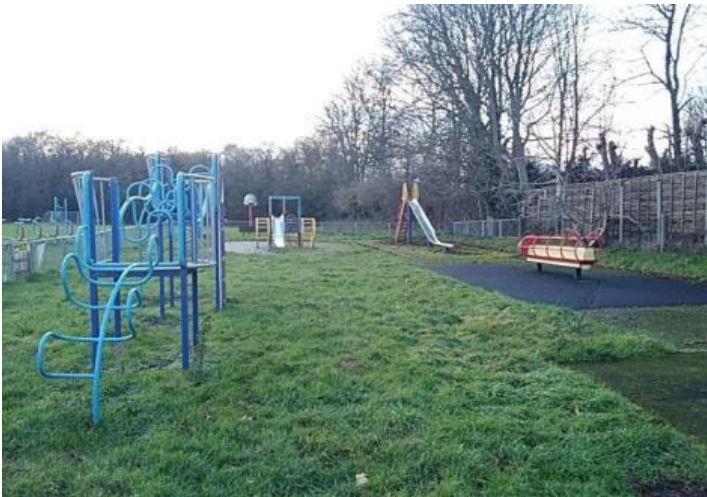
Item: Ancillary Items - Site General
Manufacturer: Owner/Operator

Finding: There is damage to the tarmac surface

Action: Repair the damaged areas of surfacing

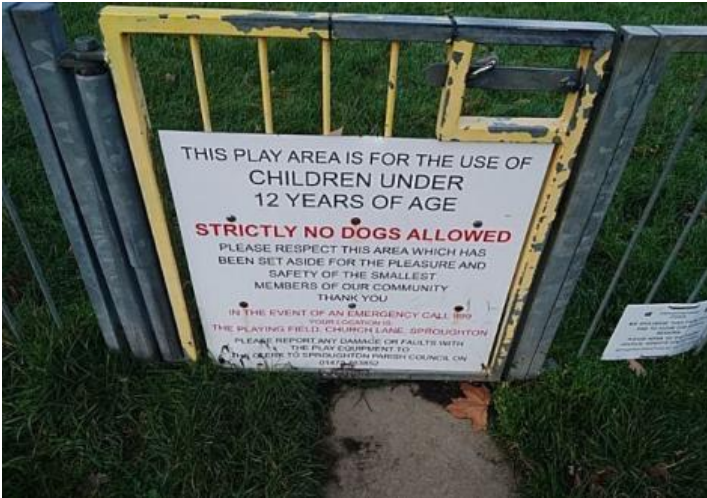
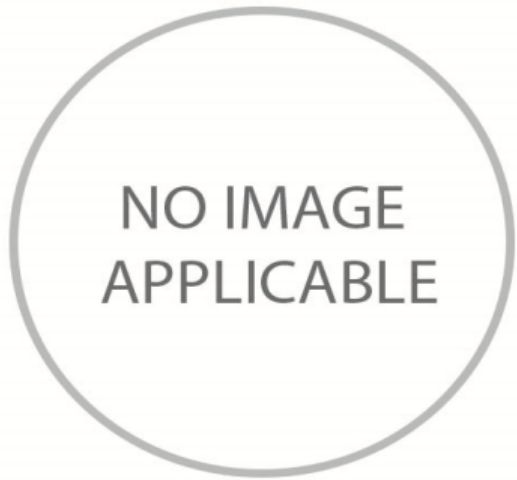
Item: Ancillary Items - Sign
Manufacturer: Owner/Operator

Finding: It is recommended that signage, with information including the site address, contact information for maintenance issues and emergency contact details are provided for the facility

Action: Provide in accordance with the recommendations

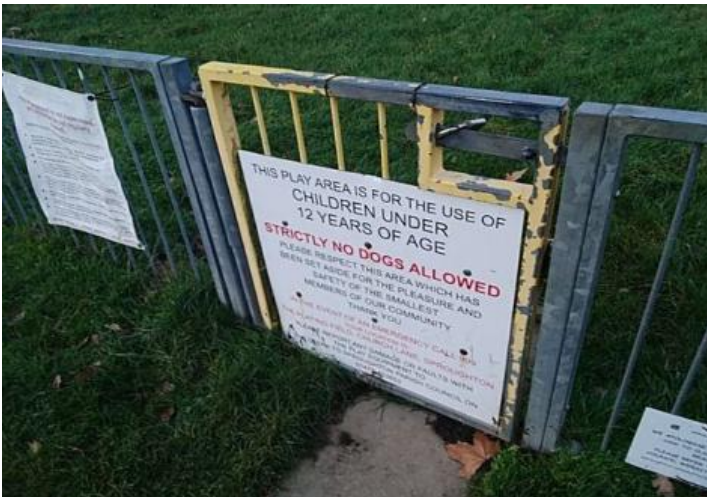
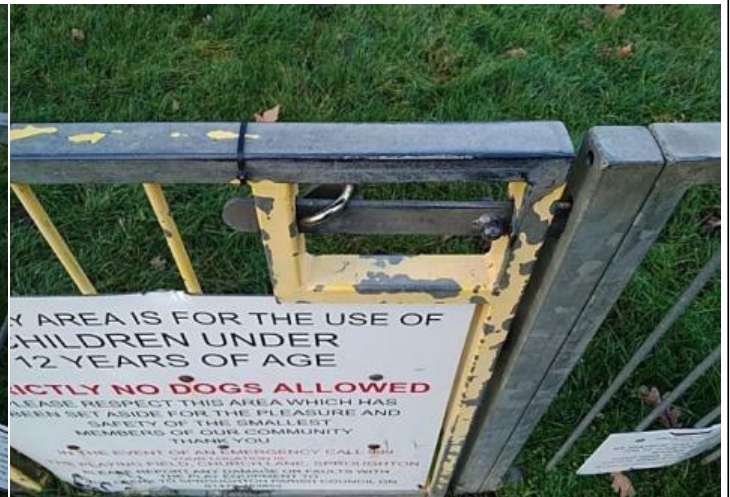
Item: Gates - Gate - Self Closing
Manufacturer: Not Identified

Finding: The gate/s was / were locked or secured at the time of the inspection and a full inspection could not be undertaken

Action: Complete inspection of gate/s when re-opened

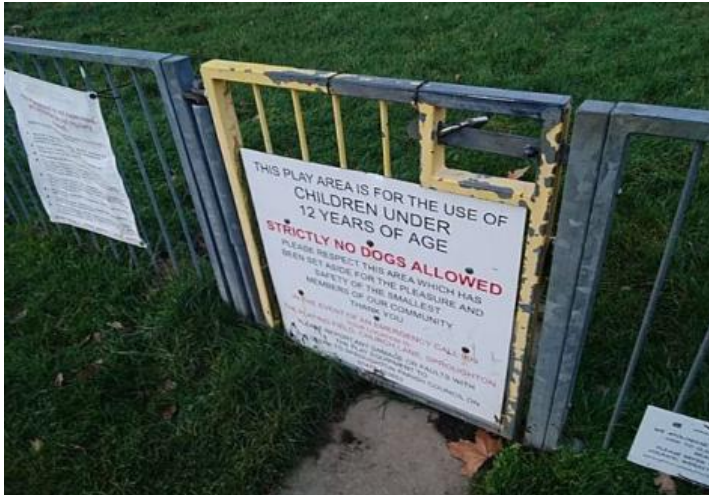
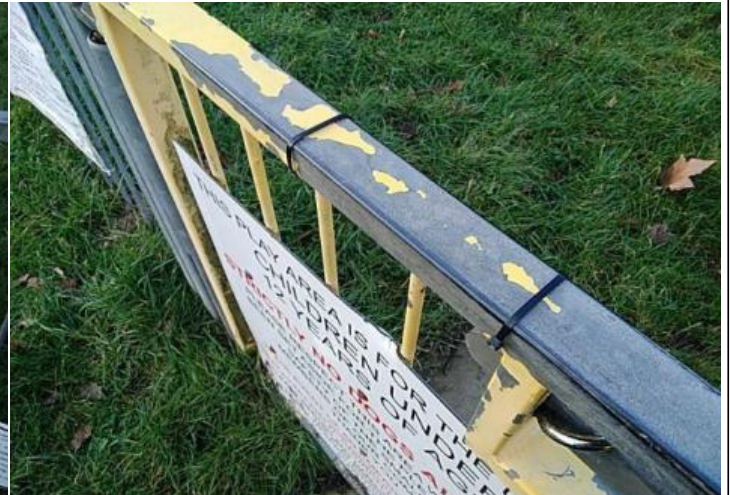
Item: Gates - Gate - Self Closing
Manufacturer: Not Identified

Finding: The paint is flaking off the metalwork

Action: Rub down and re-paint

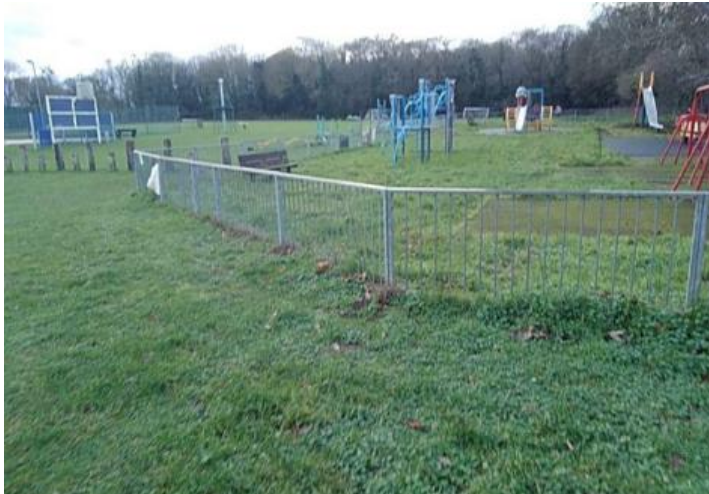
Item: Fences - Fencing - Flat Top
Manufacturer: Not Identified

Finding: There is some damage to the fence sections

Action: Monitor for any further deterioration and repair as required

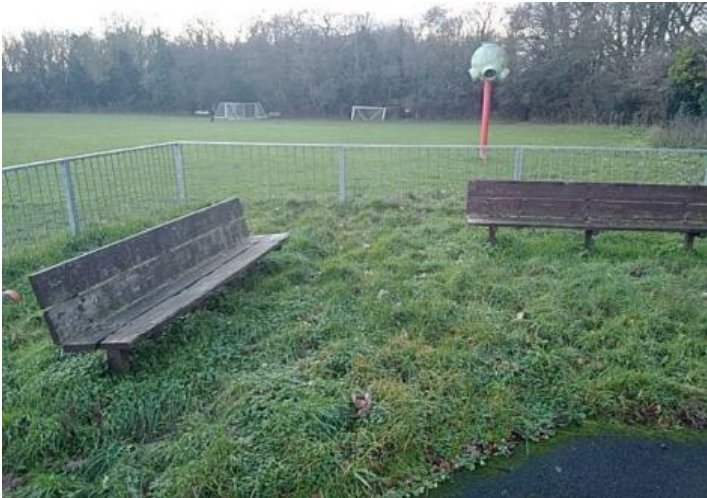
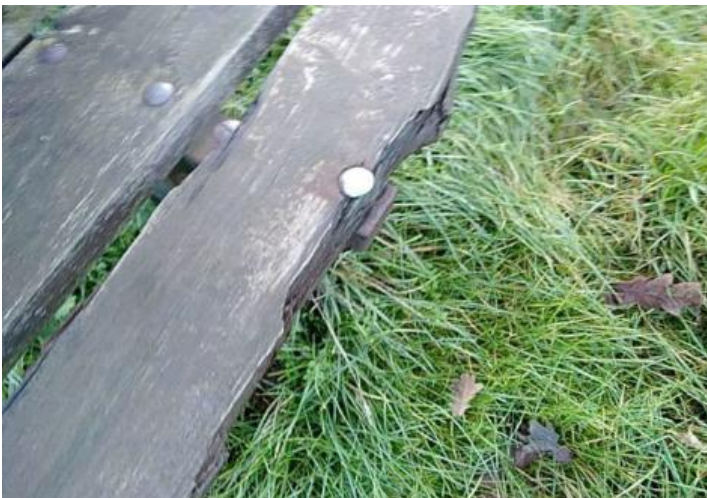
Item: Ancillary Items - Bench
Manufacturer: Not Identified

Finding: There are areas or parts of the timber on the structure that have rotted

Action: Replace all affected timbers

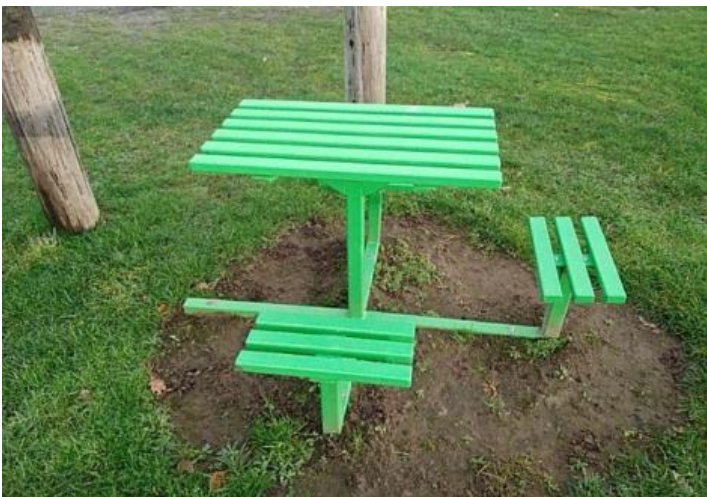
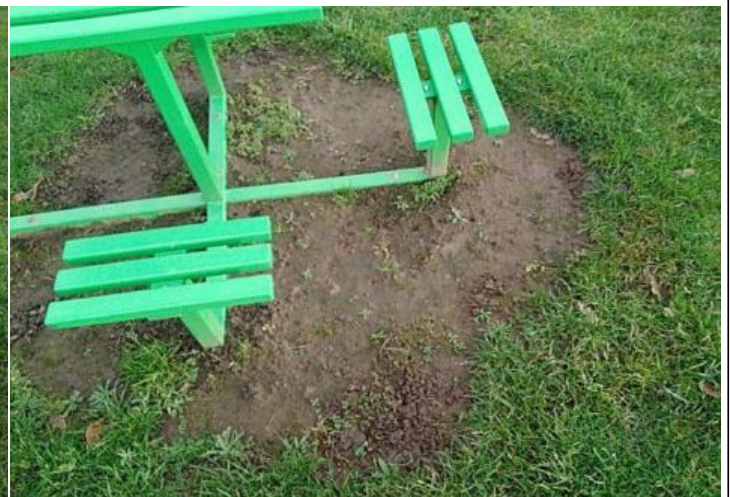
Item: Ancillary Items - Picnic Table
Manufacturer: Wicksteed Playgrounds

Finding: The area around the item has eroded and may become slippery

Action: Reinstate eroded area

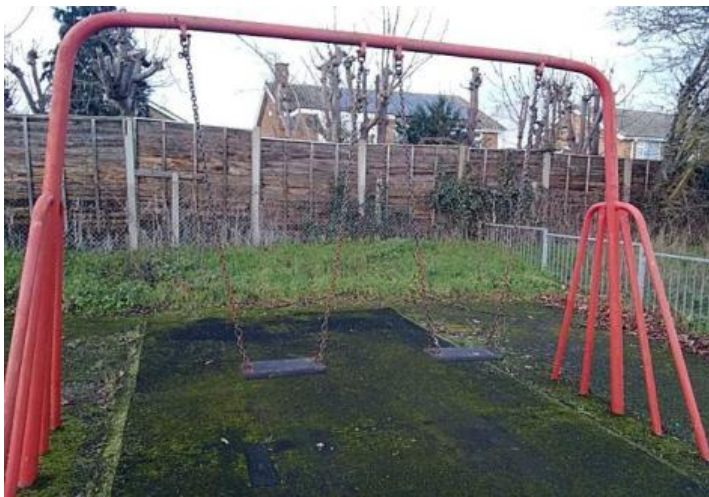
Item: Swings - 1 Bay 2 Seat (Flat)
Manufacturer: Wicksteed Playgrounds

Finding: The surface has subsided in some areas

Action: Monitor for any further deterioration and repair as required

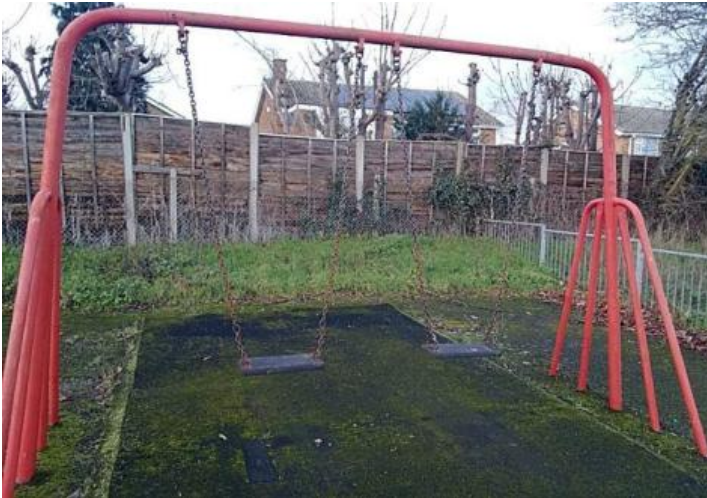
Item: Swings - 1 Bay 2 Seat (Flat)
Manufacturer: Wicksteed Playgrounds

Finding: The safety surface around the area is beginning to wear

Action: Monitor for any further deterioration and repair as required

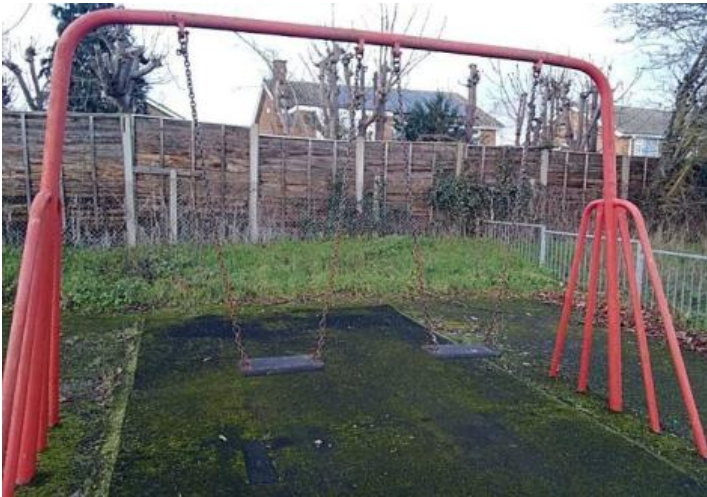
Item: Swings - 1 Bay 2 Seat (Flat)
Manufacturer: Wicksteed Playgrounds

Finding: There is some wear to the shackles

Action: Monitor for any further deterioration and replace when 40% worn

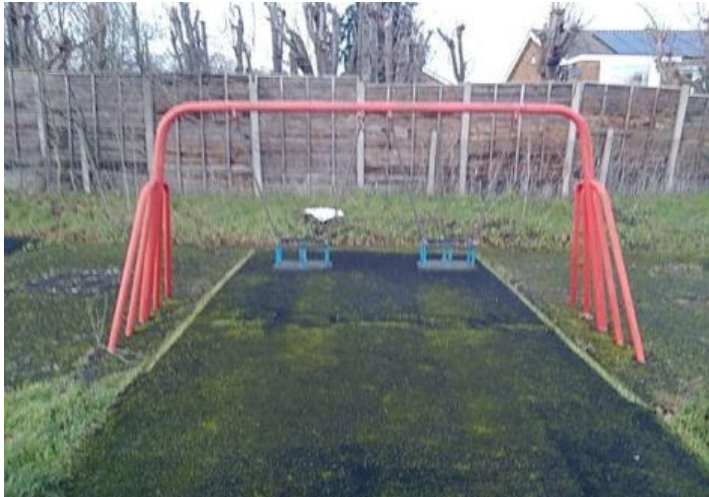
Item: Swings - 1 Bay 2 Seat (Cradle)
Manufacturer: Wicksteed Playgrounds

Finding: The safety surface around the area is beginning to wear

Action: Monitor for any further deterioration and repair as required

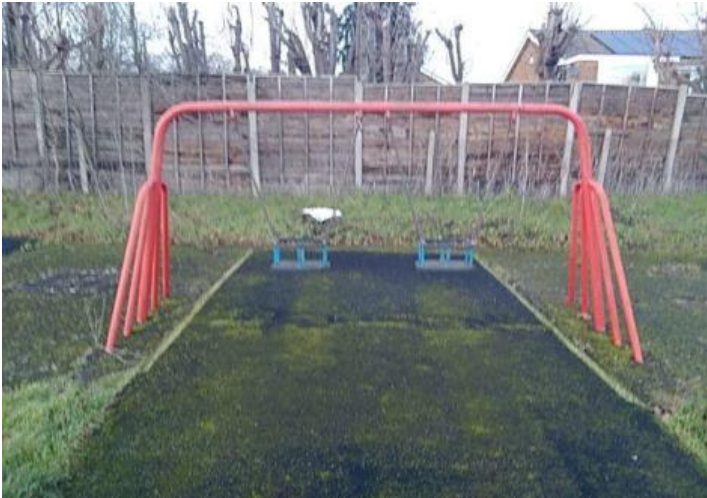
Item: Swings - 1 Bay 2 Seat (Cradle)
Manufacturer: Wicksteed Playgrounds

Finding: There is some notable evidence of chain wear

Action: Monitor for any further deterioration and replace when 40% worn

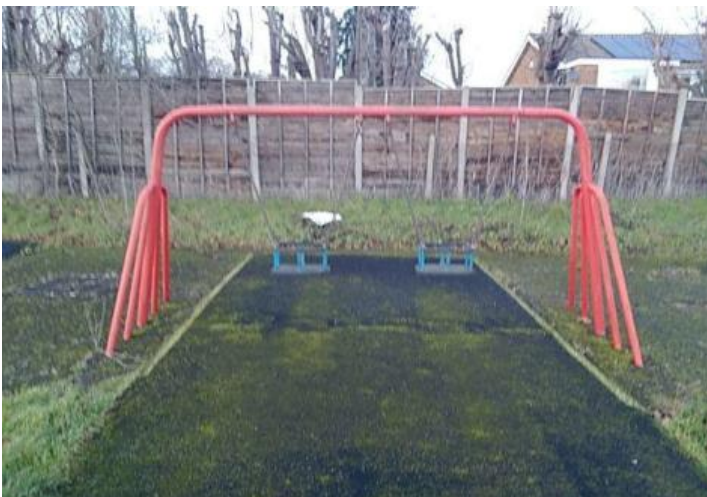
Item: Swings - 1 Bay 2 Seat (Cradle)
Manufacturer: Wicksteed Playgrounds

Finding: The bushes are worn or missing

Action: Replace worn or missing bushes

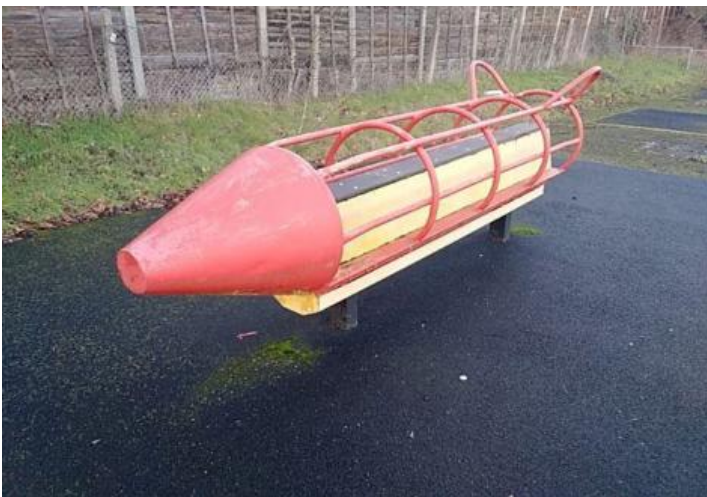
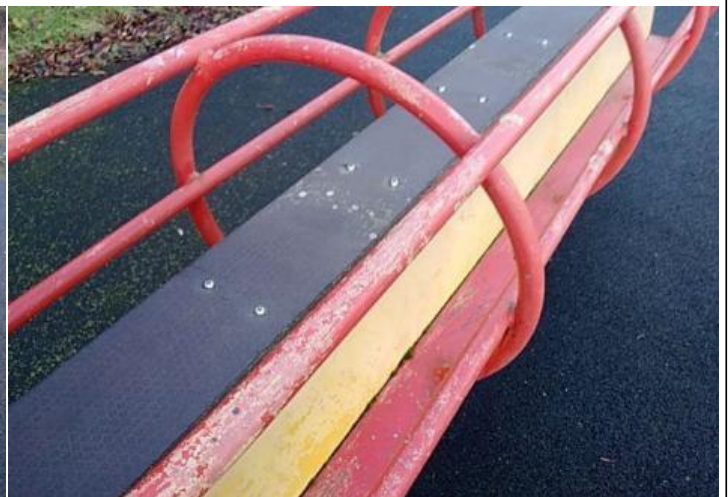
Item: Rocking Equipment - Rocking Rocket
Manufacturer: Wicksteed Playgrounds

Finding: The paint is flaking off the metalwork

Action: Rub down and re-paint

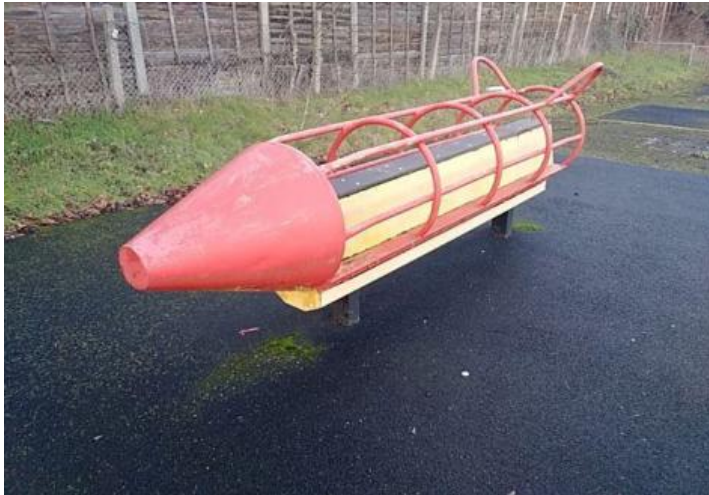
Item: Rocking Equipment - Rocking Rocket
Manufacturer: Wicksteed Playgrounds

Finding: There is surface corrosion present on the item

Action: Consider treating the item

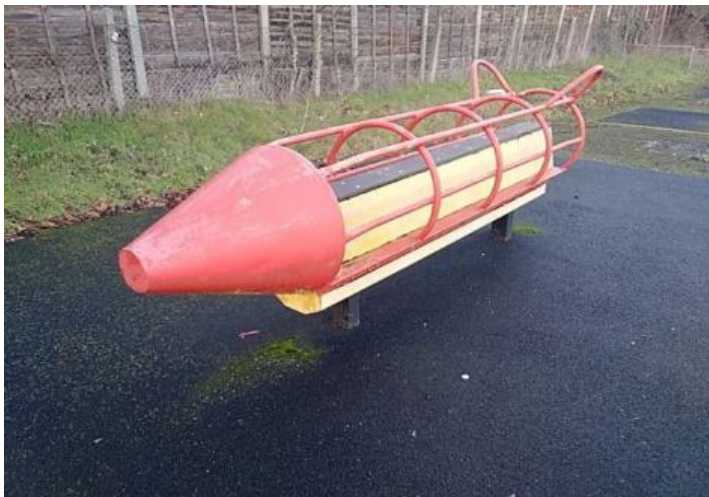
Item: Rocking Equipment - Rocking Rocket
Manufacturer: Wicksteed Playgrounds

Finding: There is no gaiter protection for accessible moving parts (possible shear trap) as recommended in BS EN 1176 Part 1; 4.2.6 Moving Parts

Action: Monitor - No remedial work recommended

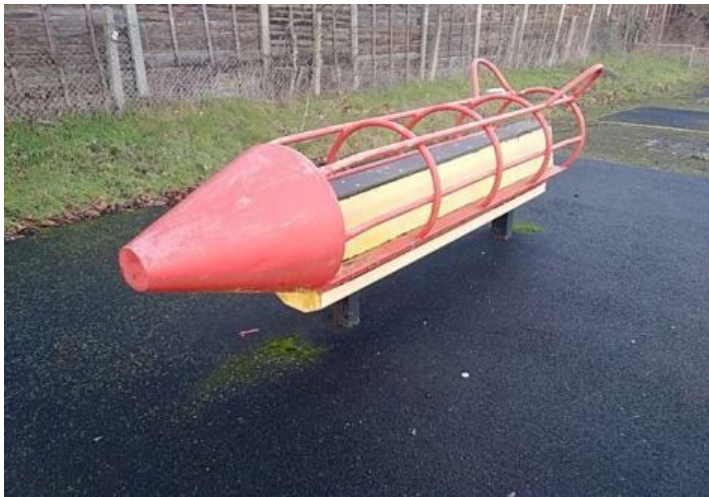
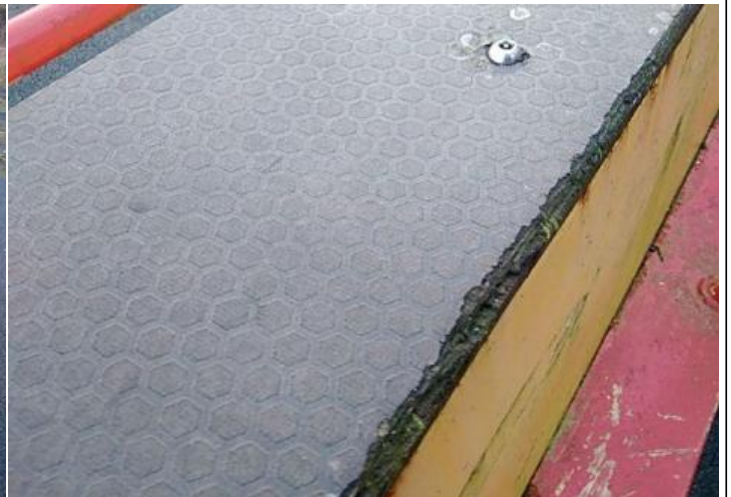
Item: Rocking Equipment - Rocking Rocket
Manufacturer: Wicksteed Playgrounds

Finding: Parts of the timber are rough or splintered

Action: Remove all rough or sharp edges

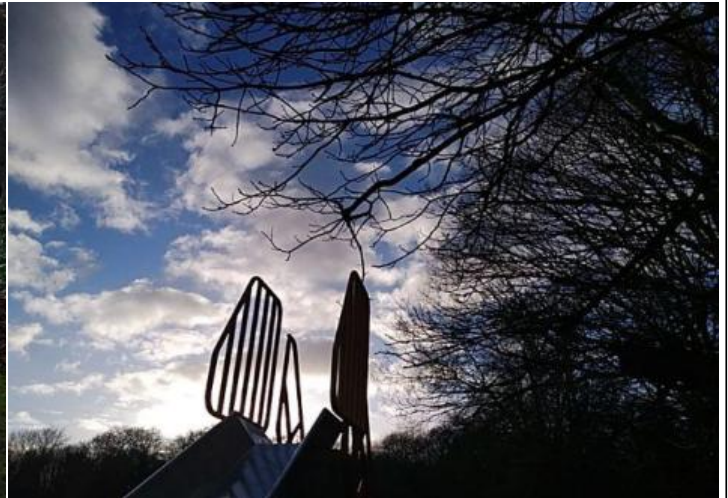
Item: Other - Free Standing Slide
Manufacturer: Wicksteed Playgrounds

Finding: The tree canopy overhangs the equipment and is less than 2.0m away

Action: Lift tree canopy to ensure a minimum clearance of 2.0m from the equipment

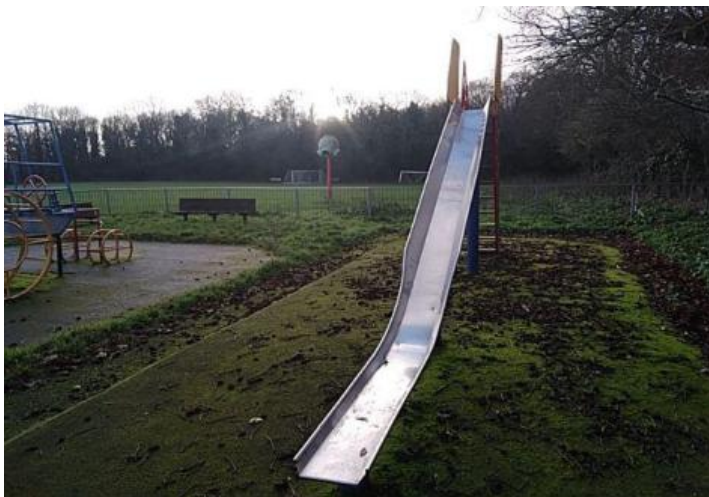
Item: Other - Free Standing Slide
Manufacturer: Wicksteed Playgrounds

Finding: There are a number of dents in the slide surface

Action: Monitor for any further deterioration and repair as required

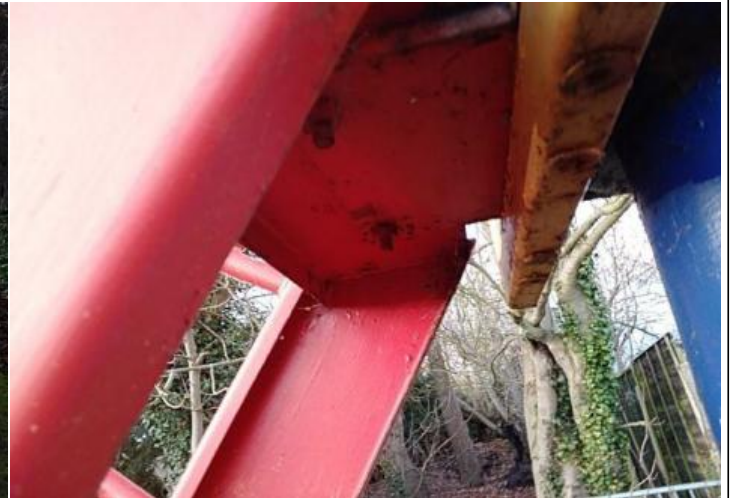
Item: Other - Free Standing Slide
Manufacturer: Wicksteed Playgrounds

Finding: There are projecting bolt thread(s) present

Action: Remove excess thread length and deburr or provide cap

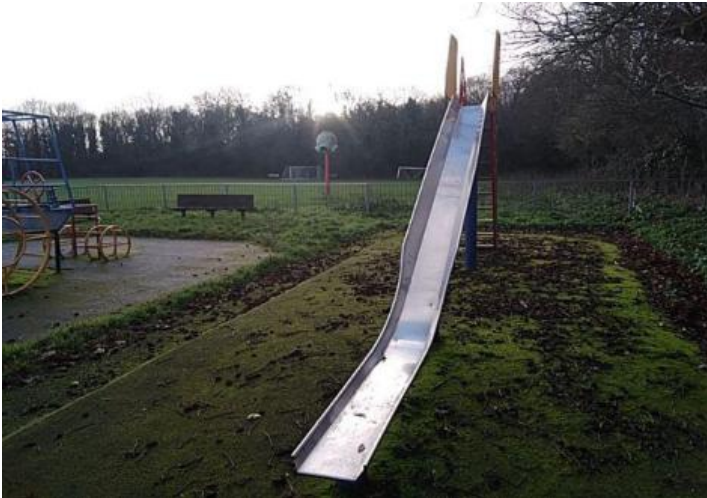
Item: Other - Free Standing Slide
Manufacturer: Wicksteed Playgrounds

Finding: There is surface corrosion present on the item

Action: Consider treating the item

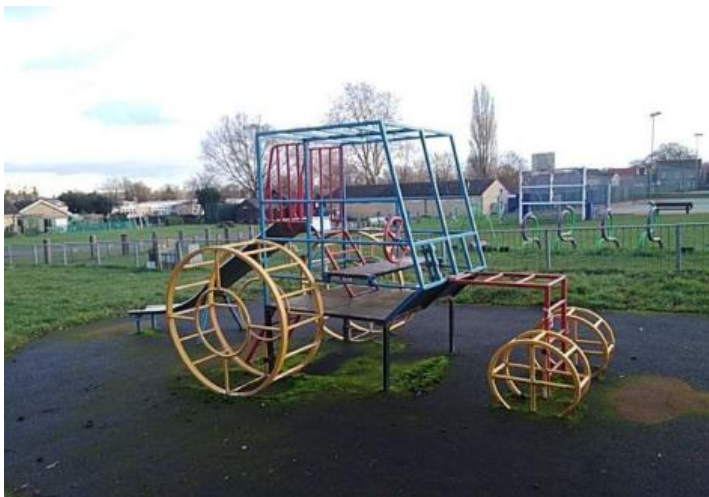
Item: Activity Equipment - Tractor
Manufacturer: Wicksteed Playgrounds

Finding: There are falls in excess of 600mm between adjacent components on the structure, in contravention of the recommendations set out in BS EN 1176 Part 1; 4.2.8.4

Action: Monitor - No remedial work recommended

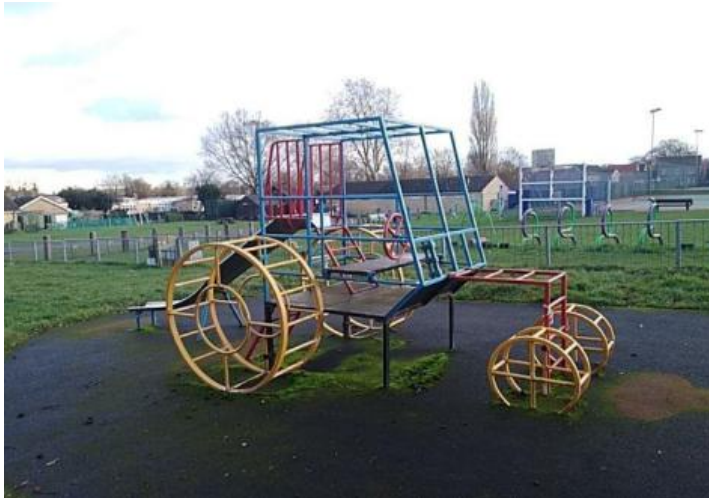
Item: Activity Equipment - Tractor
Manufacturer: Wicksteed Playgrounds

Finding: The item fails to meet the requirements of BS EN 1176 Part 1 4.2.7.2 for head and neck entrapment in the framework

Action: Monitor - No remedial work recommended

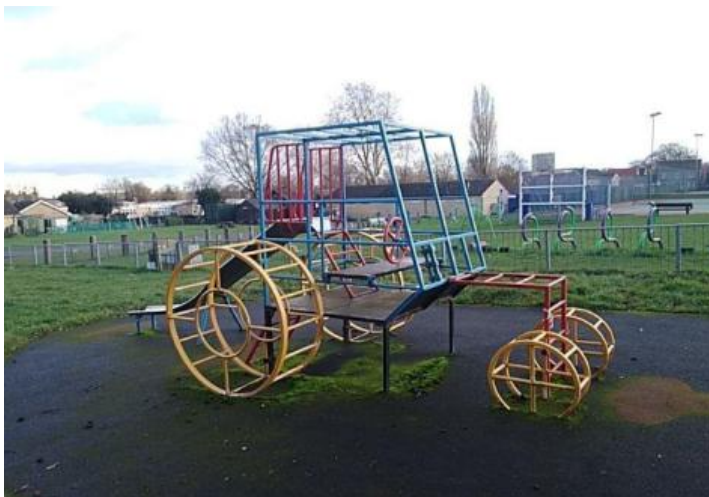
Item: Activity Equipment - Tractor
Manufacturer: Wicksteed Playgrounds

Finding: There is/are finger entrapment/s in the starting section of the slide and the item fails to meet the requirements of BS EN 1176 Part 1 4.2.7.6 Entrapment of fingers

Action: Monitor - No remedial work recommended

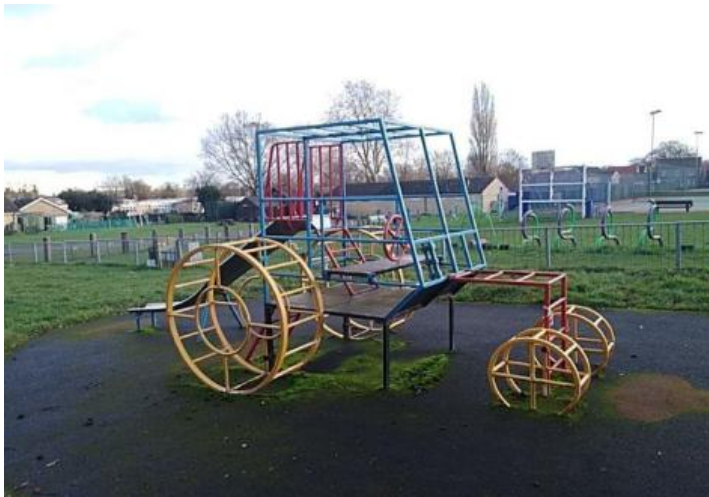
Item: Activity Equipment - Tractor
Manufacturer: Wicksteed Playgrounds

Finding: The fixings have corroded excessively

Action: Replace all corroded fixings

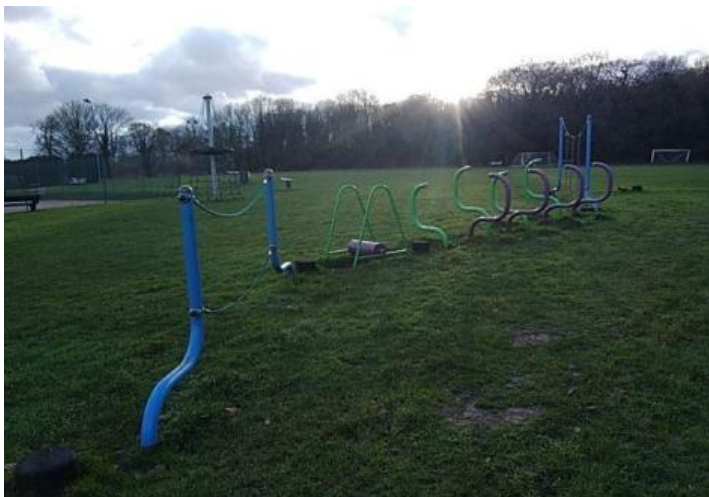
Item: Activity Equipment - Activity Trail
Manufacturer: Wicksteed Playgrounds

Finding: The paintwork on this item has been damaged or worn exposing the metal underneath which is rusting

Action: Treat any rusting components and repaint

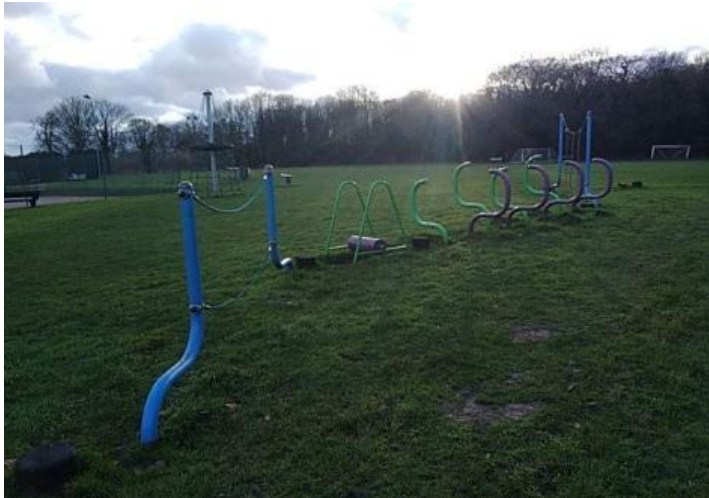
Item: Activity Equipment - Activity Trail
Manufacturer: Wicksteed Playgrounds

Finding: The chain openings are in excess of 8.6mm and do not meet the recommendations of BS EN 1176 Part 1

Action: Monitor - No remedial work recommended

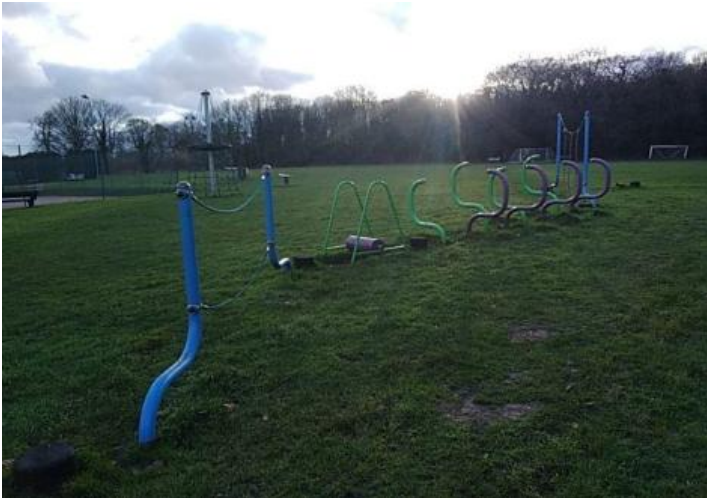
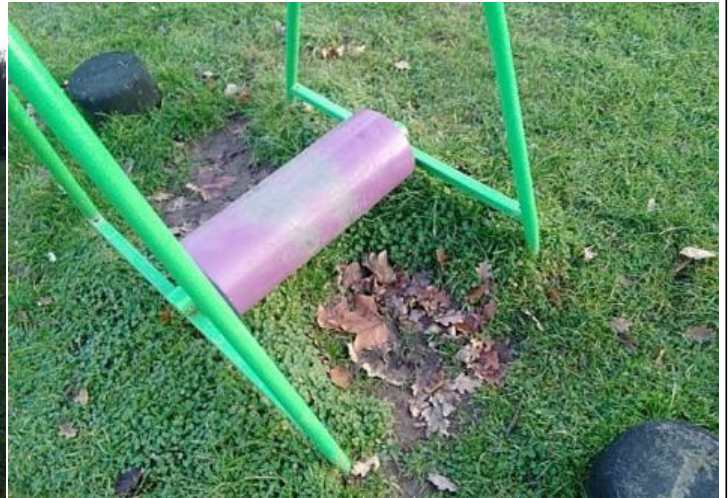
Item: Activity Equipment - Activity Trail
Manufacturer: Wicksteed Playgrounds

Finding: The area around the item has eroded and may become slippery

Action: Reinststate eroded area

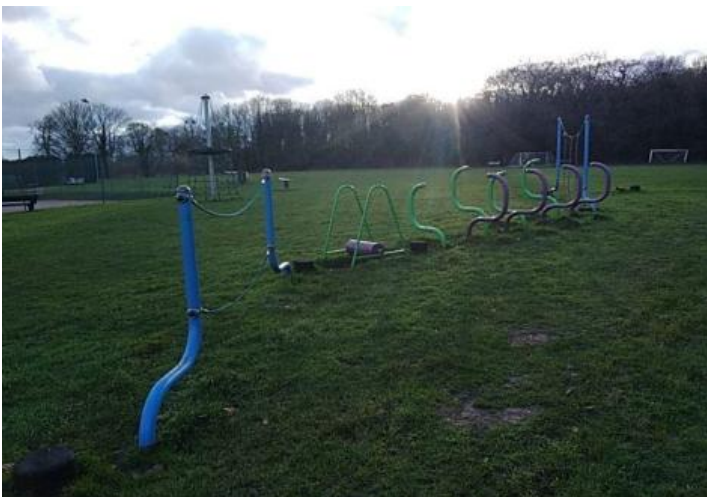
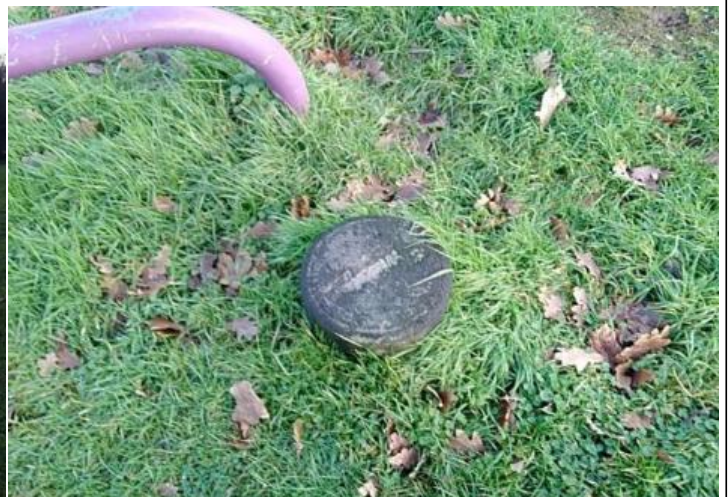
Item: Activity Equipment - Activity Trail
Manufacturer: Wicksteed Playgrounds

Finding: There is algae or moss on the surface of the equipment

Action: Clean and treat appropriately
