the **play inspection** company

Annual Inspection

Babergh District Council

Sproughton Playing Fields

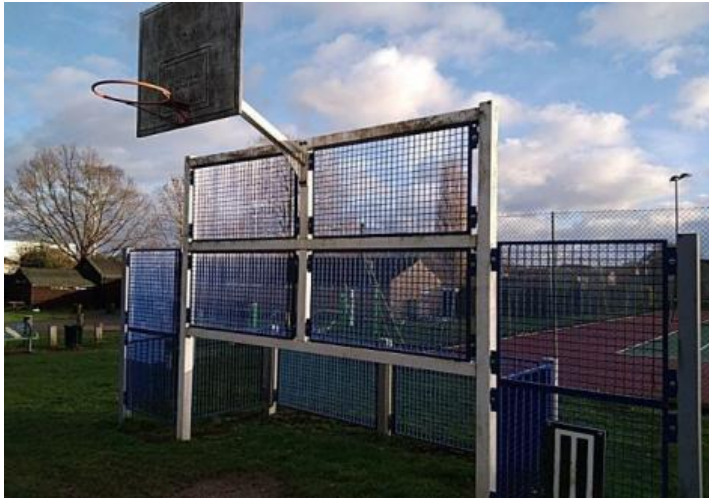
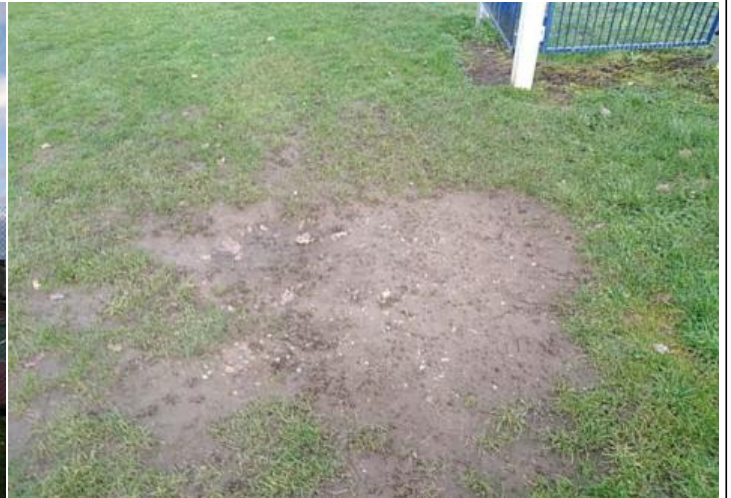
Item: Multi Use Games Area - Goal End
Manufacturer: Wicksteed Playgrounds

Finding: The area around the item has eroded and may become slippery

Action: Reinststate eroded area

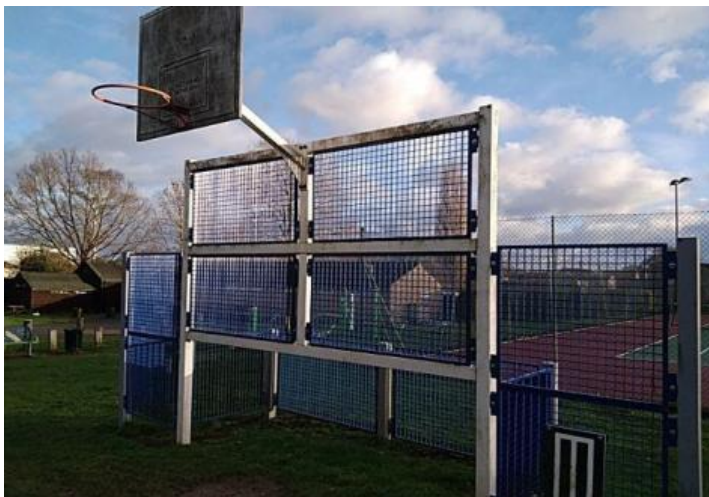
Item: Multi Use Games Area - Goal End
Manufacturer: Wicksteed Playgrounds

Finding: There is/are finger entrapments in the framework and the item fails to meet the requirements of BS EN 15312 Clause 4.4.2.2 Entrapment of fingers

Action: Monitor - No remedial work recommended

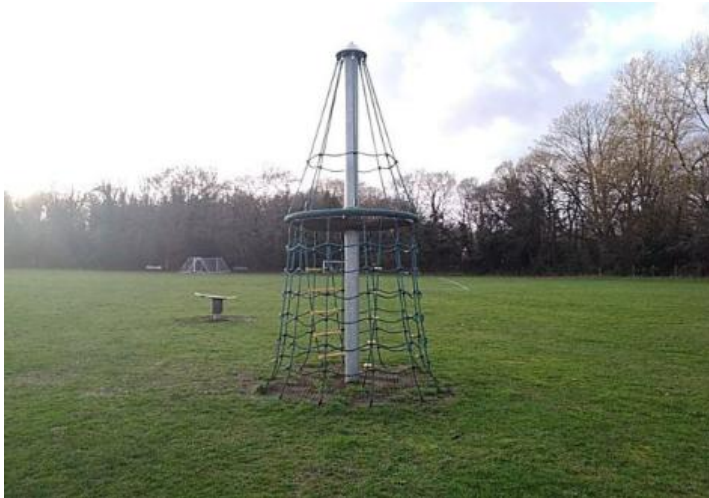
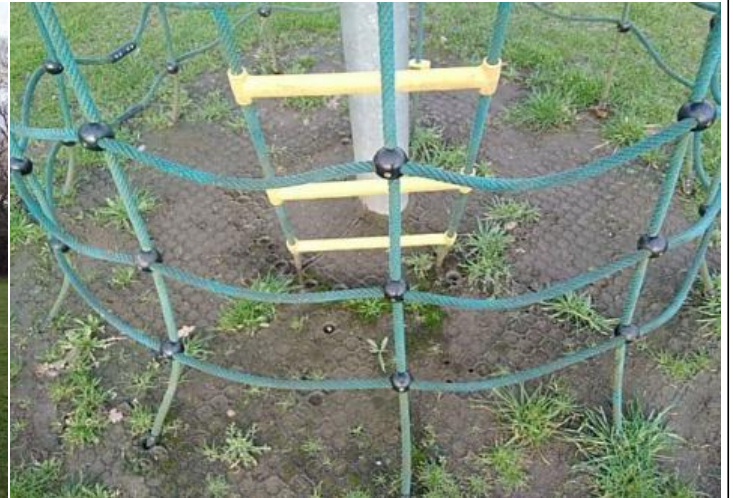
Item: Activity Equipment - Net Climber
Manufacturer: Wicksteed Playgrounds

Finding: The grass mats are silted up, the soil is compacted and the area will become very slippery when the soil is wet. **Action:** Reinstate as required

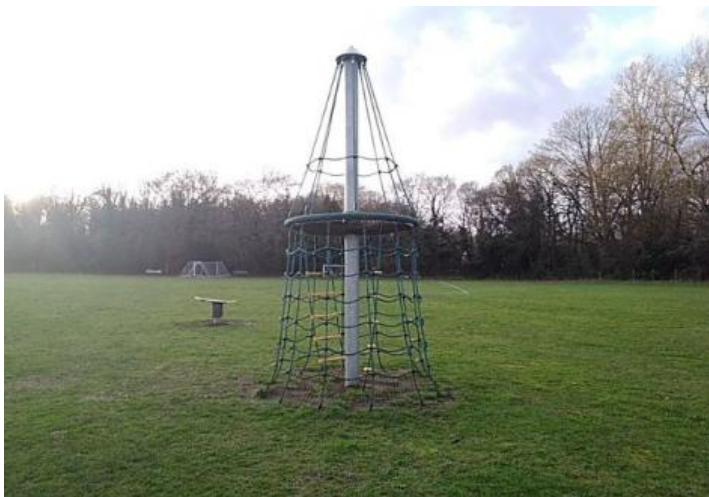
Item: Activity Equipment - Net Climber
Manufacturer: Wicksteed Playgrounds

Finding: The ropes/nets are worn/damaged in places **Action:** Monitor for any further deterioration and repair or replace as required

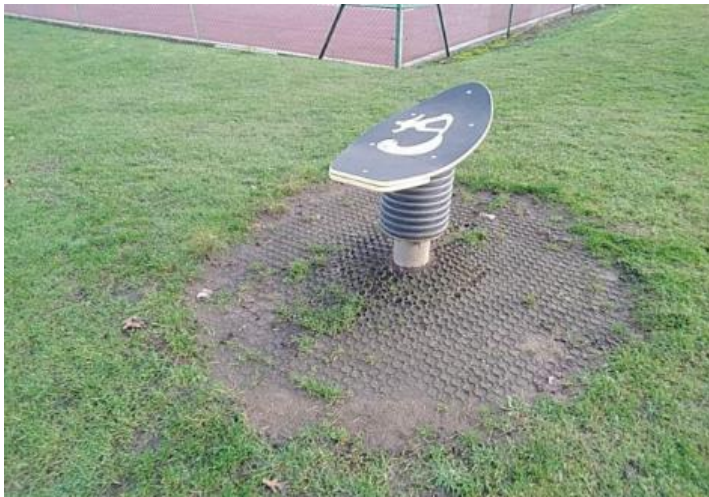
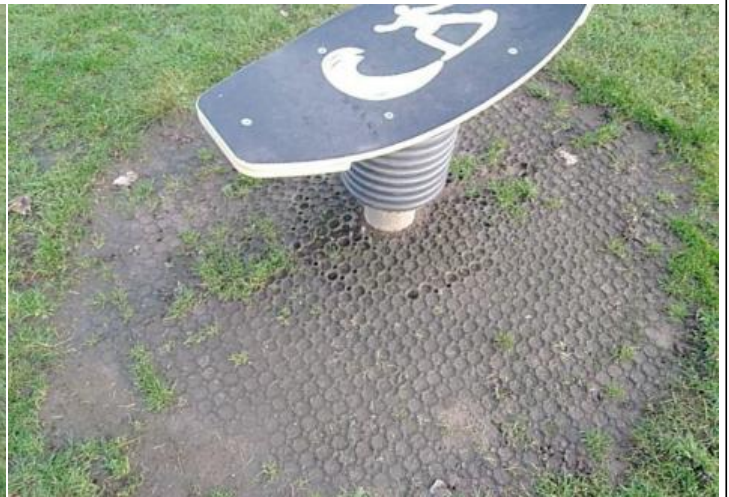
Item: Rotor Play - Surf Spinner
Manufacturer: Wicksteed Playgrounds

Finding: The grass mats are silted up, the soil is compacted and the area will become very slippery when the soil is wet.
Action: Reinstate as required

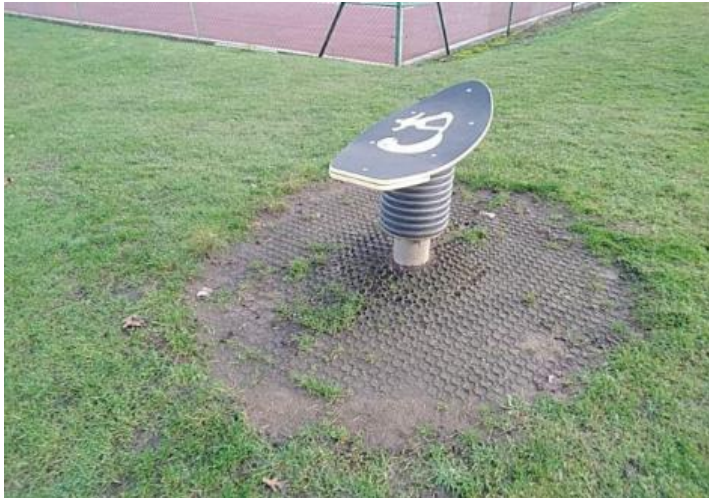
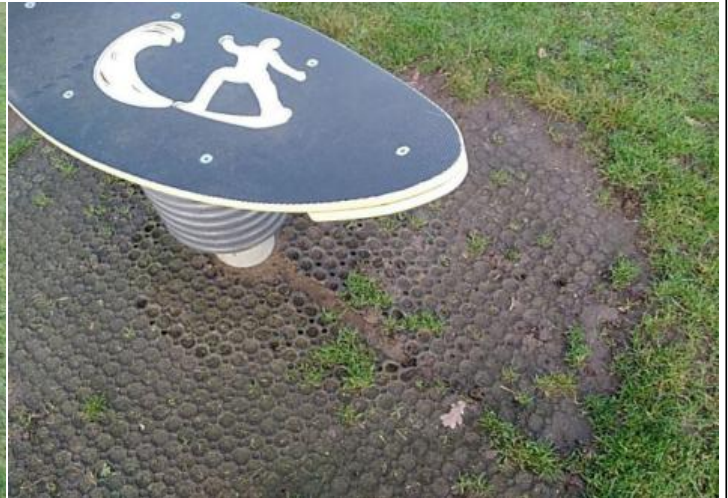
Item: Rotor Play - Surf Spinner
Manufacturer: Wicksteed Playgrounds

Finding: There are gaps opening between the grass mat tiles

Action: Provide additional ties or secure / reinstate surface tiles

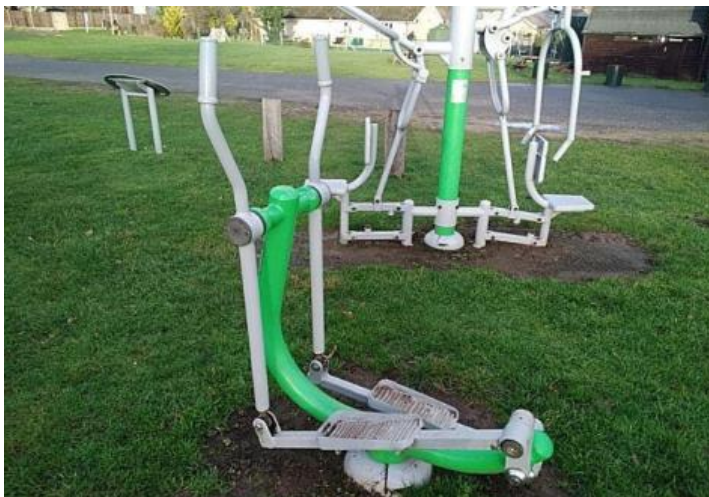
Item: Outdoor Fitness Equipment - Cross Trainer
Manufacturer: Wicksteed Playgrounds

Finding: There are gaps between 8 and 60mm creating a potential crush/shear point in contravention of the requirements of BS EN 16630

Action: Monitor - No remedial work recommended

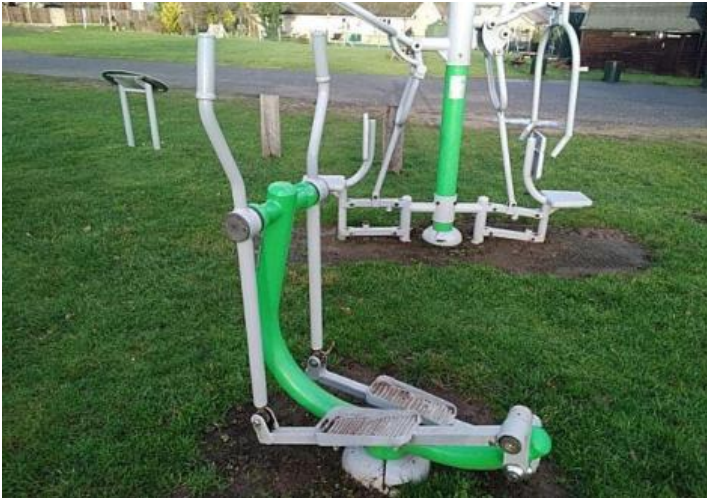
Item: Outdoor Fitness Equipment - Cross Trainer **Risk Level:** V - Very Low Risk
Manufacturer: Wicksteed Playgrounds **Surface:** Grass Matrix Tiles

Finding: There is/are bolt cap covers missing or damaged on the item **Action:** Replace missing or damaged bolt cap covers

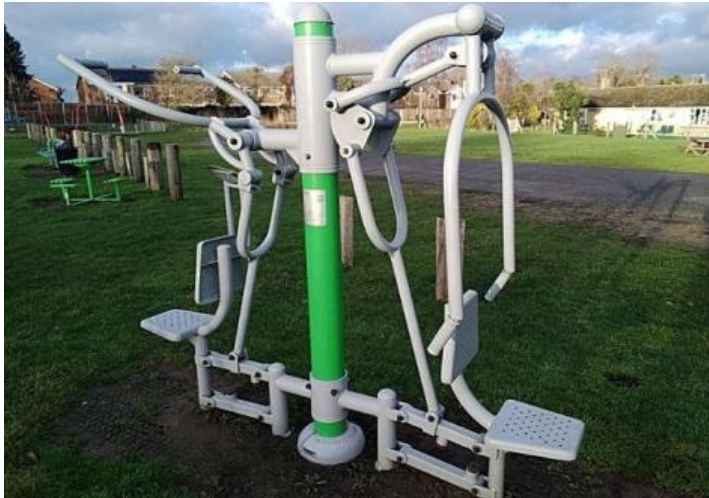
Item: Outdoor Fitness Equipment - Chest Press
Manufacturer: Wicksteed Playgrounds

Finding: There is/are bolt cap covers missing or damaged on the item

Action: Replace missing or damaged bolt cap covers

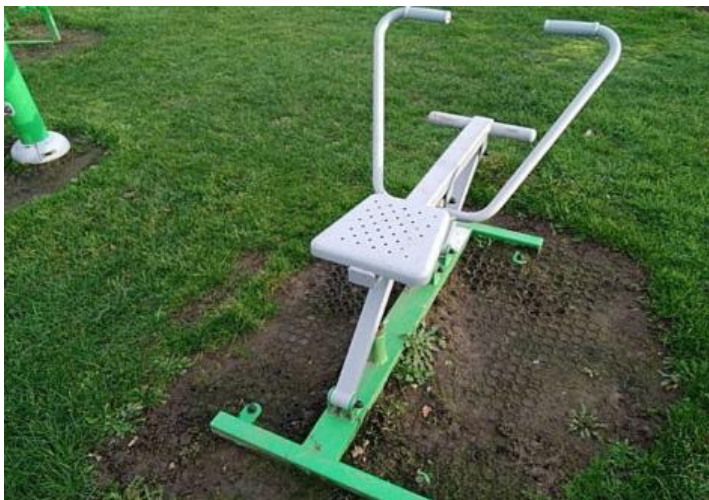
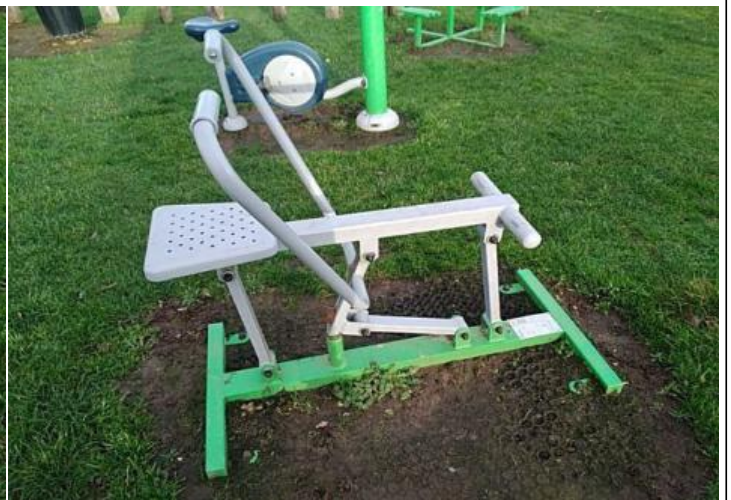
Item: Outdoor Fitness Equipment - Rower
Manufacturer: Wicksteed Playgrounds

Finding: BS EN 16630 - 4.3.1 states that fitness equipment shall be designed so when at rest, the equipment shall automatically adjust so that the equipment is ready for the next user

Action: Service the item

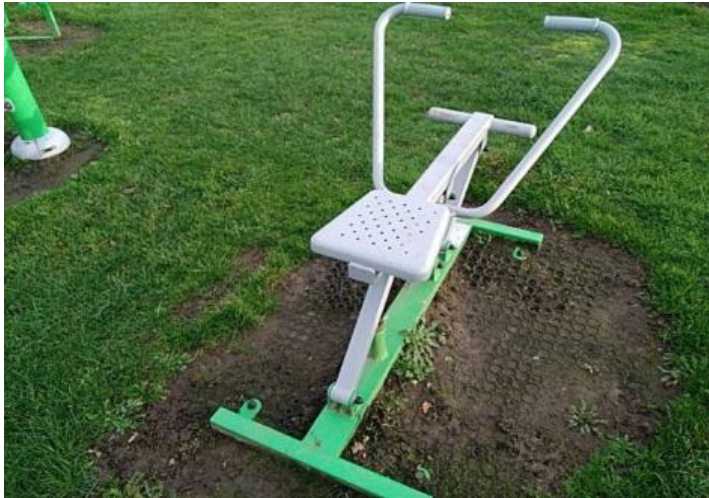
Item: Outdoor Fitness Equipment - Rower
Manufacturer: Wicksteed Playgrounds

Finding: There is/are bolt cap covers missing or damaged on the item

Action: Replace missing or damaged bolt cap covers

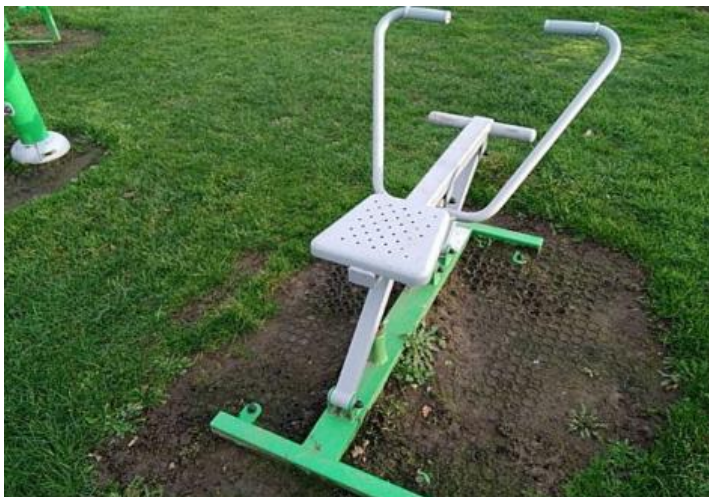
Item: Outdoor Fitness Equipment - Rower
Manufacturer: Wicksteed Playgrounds

Finding: There are gaps between 8 and 60mm creating a potential crush/shear point in contravention of the requirements of BS EN 16630

Action: Monitor - No remedial work recommended
